Access Compliance Report Public Rights-of-Way (Curb Ramps)

Intersection ID: 15301Main Street:E_INDEPENDENCE_BVCross Street:WESTCHESTER_BVLocation:NWADA ID: ACCD026B9A85Ramp Type:PerpInitial Pass/Fail:FailOverall Compliance:NoSeverity Score:10

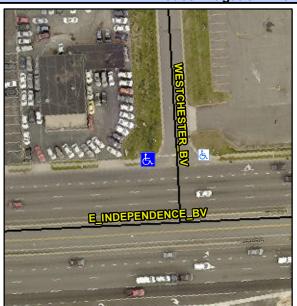
orrossible solution		r leid Measurements/Component Compnance					
Possible Solutions:		Compliance Description		Data	Data Compliance Description		
Remove & Replace Entire Ra	ımp.	N/A	Ramp Length (in)	74.5	Yes	Ramp Slope (%)	6.1

•	No	Ramp Width (in)	43.0	No	Ramp XSlope (%)	2.3
		N/A	Flare Type LT	N/A	N/A	Flare Type RT	N/A
		N/A	Flare Slope LT (%)	N/A	N/A	Flare Slope RT (%)	N/A
		N/A	Flare Traversable LT?	N/A	N/A	Flare Traversable RT?	N/A
		N/A	Landing Length (in)	N/A	N/A	DWS Provided?	N/A
Surveyor Notes:		N/A	Landing Width (in)	N/A	N/A	DWS Contrast?	N/A
N/A		N/A	Landing Slope (%)	N/A	N/A	DWS Length (in)	N/A
t to the second		N/A	Landing X Slope (%)	N/A	N/A	DWS Full Width?	N/A
		N/A	Landing Curb? (Y/N)	N/A	N/A	DWS Offset (in)	N/A
9		N/A	Shared Landing?	N/A			
PROW/ADA:		N/A	Gutter Ponding?	N/A	N/A	Gutter Slope (%)	N/A
Not Found, R304.5.1, R304.5	5.3	N/A	Gutter Lip Ht (in)	N/A	N/A	Gutter X Slope (%)	N/A
<u></u>		N/A	Painted X Walk1?	No	N/A	Painted X Walk2?	N/A
			X Walk 1 Direction	To E		X Walk 2 Direction	N/A
		N/A	X Walk 1 Width (in)	N/A	N/A	X Walk 2 Width (in)	N/A
			X Walk 1 Slope (%)	2.2		X Walk 2 Slope (%)	N/A
			X Walk 1 X Slope (%)	1.0		X Walk 2 X Slope (%)	N/A
