Access Compliance Report

Public Rights-of-Way

(Curb Ramps)

Intersection ID: 29395	Main Street: REEDY_PLANTATION_RD	Cross Street: SILVERFIELD_LN	Location: NE
ADA ID: ACCE89EA1FE2	Ramp Type: PerpDiag	Initial Pass/Fail: Fail	Overall Compliance: No
Severity Score: 37.5			
Codes/Mitigation Info/Possible Solution		Field Measurements/Component Compliance

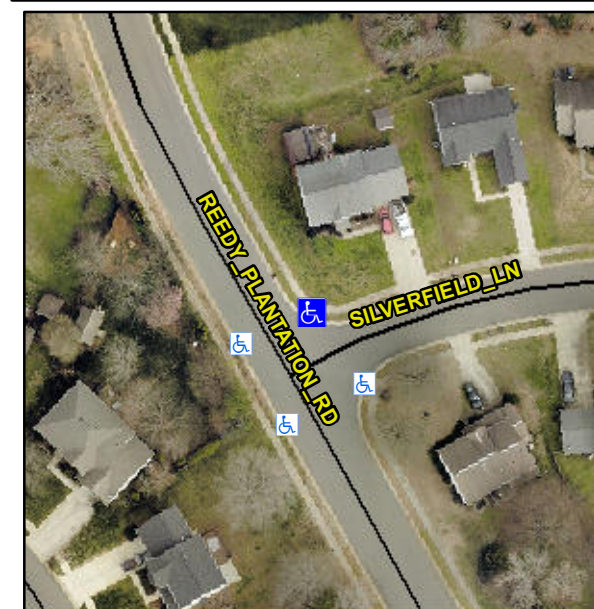
R304.2.2, R304.5.3

Compliance	Description	Data	Compliance	Description	Data
N/A	Ramp Length (in)	48.0	No	Ramp Slope (%)	9.2
Yes	Ramp Width (in)	48.0	No	Ramp XSlope (%)	7.6
N/A	Flare Type LT	N/A	N/A	Flare Type RT	N/A
N/A	Flare Slope LT (%)	N/A	N/A	Flare Slope RT (%)	N/A
N/A	Flare Traversable LT?	N/A	N/A	Flare Traversable RT?	N/A
N/A	Landing Length (in)	N/A	N/A	DWS Provided?	N/A
N/A	Landing Width (in)	N/A	N/A	DWS Contrast?	N/A
N/A	Landing Slope (%)	N/A	N/A	DWS Length (in)	N/A
N/A	Landing X Slope (%)	N/A	N/A	DWS Full Width?	N/A
N/A	Landing Curb? (Y/N)	N/A	N/A	DWS Offset (in)	N/A
N/A	Shared Landing?	N/A			
N/A	Gutter Ponding?	N/A	N/A	Gutter Slope (%)	N/A
N/A	Gutter Lip Ht (in)	N/A	N/A	Gutter X Slope (%)	N/A
N/A	Painted X Walk1?	No	N/A	Painted X Walk2?	No
	X Walk 1 Direction	To N		X Walk 2 Direction	To S
N/A	X Walk 1 Width (in)	N/A	N/A	X Walk 2 Width (in)	N/A
	X Walk 1 Slope (%)	4.8		X Walk 2 Slope (%)	3.6
	X Walk 1 X Slope (%)	5.5		X Walk 2 X Slope (%)	5.2

N/A	Ramp inside XWalk1?	N/A	N/A	Ramp inside XWalk2?	N/A
	Road Slope (%)	6.6	N/A	Clear Space?	N/A
	Road X Slope (%)	0.8	N/A	Clear Space to XWalk (in)	N/A
N/A	Any Obstructions?	N/A	N/A	Storm Grate/Utility Hazard?	N/A
	Obstruction Type			Storm Grate/Utility Type	
		N/A			N/A
		Yes		Surface Condition? (G/P)	Good

Remove & Replace Curb Ramp With Two New Directional Ramps or Equivalent.
