Access Compliance Report

Public Rights-of-Way

(Curb Ramps)

Intersection ID: 10020376		Main Street: BALLANTYNE CORPORATE PCross Street: N/A		Location: SE	
ADA ID: ACE8C9325957		Ramp Type: Perp		Initial Pass/Fail: Fail	
		Overall Compliance: No		Severity Score: 25	
Codes/Mitigation Info/Possible Solution			Field Measurements/Component Compliance

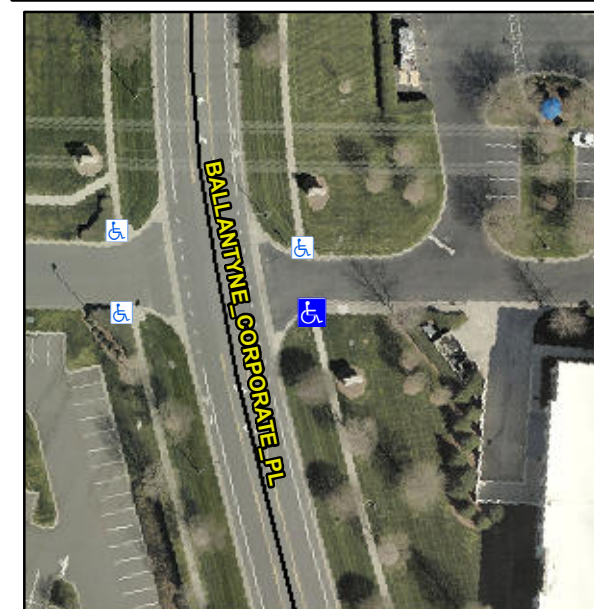
Compliance	Description	Data	Compliance	Description	Data
N/A	Ramp Length (in)	72.0	Yes	Ramp Slope (%)	7.0
Yes	Ramp Width (in)	48.0	No	Ramp XSlope (%)	7.3
N/A	Flare Type LT	N/A	N/A	Flare Type RT	N/A
N/A	Flare Slope LT (%)	N/A	N/A	Flare Slope RT (%)	N/A
N/A	Flare Traversable LT?	N/A	N/A	Flare Traversable RT?	N/A
N/A	Landing Length (in)	N/A	N/A	DWS Provided?	N/A
N/A	Landing Width (in)	N/A	N/A	DWS Contrast?	N/A
N/A	Landing Slope (%)	N/A	N/A	DWS Length (in)	N/A
N/A	Landing X Slope (%)	N/A	N/A	DWS Full Width?	N/A
N/A	Landing Curb? (Y/N)	N/A	N/A	DWS Offset (in)	N/A
N/A	Shared Landing?	N/A			
N/A	Gutter Ponding?	N/A	N/A	Gutter Slope (%)	N/A
N/A	Gutter Lip Ht (in)	N/A	N/A	Gutter X Slope (%)	N/A
N/A	Painted X Walk1?	No	N/A	Painted X Walk2?	N/A
	X Walk 1 Direction	To N		X Walk 2 Direction	N/A
N/A	X Walk 1 Width (in)	N/A	N/A	X Walk 2 Width (in)	N/A
	X Walk 1 Slope (%)	2.6		X Walk 2 Slope (%)	N/A
	X Walk 1 X Slope (%)	2.7		X Walk 2 X Slope (%)	N/A

N/A	Ramp inside XWalk1?	N/A	N/A	Ramp inside XWalk2?	N/A
	Road Slope (%)	N/A	N/A	Clear Space?	N/A
	Road X Slope (%)	N/A	N/A	Clear Space to XWalk (in)	N/A
N/A	Any Obstructions?	N/A	N/A	Storm Grate/Utility Hazard?	N/A
	Obstruction Type			Storm Grate/Utility Type	
		N/A			N/A
			Yes	Surface Condition? (G/P)	Good

Possible Solutions:

Remove & Replace Entire Ramp.

R304.5.3

Total Cost:

\$ 1850.00
