# Access Compliance Report

## Public Rights-of-Way

### (Curb Ramps)

Intersection ID: 10025384	Main Street: E_9TH_ST	Cross Street: N/A	Location: S
ADA ID: ACEA553D261B	Ramp Type: PerpDiag	Initial Pass/Fail: Fail	Overall Compliance: No
Severity Score: 13.75			
Codes/Mitigation Info/Possible Solution		Field Measurements/Component Compliance

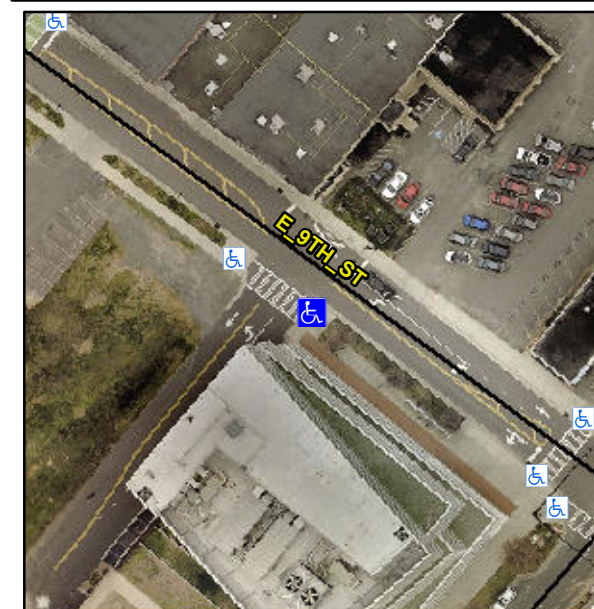
Compliance	Description	Data	Compliance	Description	Data
N/A	Ramp Length (in)	59.0	No	Ramp Slope (%)	9.1
Yes	Ramp Width (in)	48.0	No	Ramp XSlope (%)	3.0
N/A	Flare Type LT	N/A	N/A	Flare Type RT	N/A
N/A	Flare Slope LT (%)	N/A	N/A	Flare Slope RT (%)	N/A
N/A	Flare Traversable LT?	N/A	N/A	Flare Traversable RT?	N/A
N/A	Landing Length (in)	N/A	N/A	DWS Provided?	N/A
N/A	Landing Width (in)	N/A	N/A	DWS Contrast?	N/A
N/A	Landing Slope (%)	N/A	N/A	DWS Length (in)	N/A
N/A	Landing X Slope (%)	N/A	N/A	DWS Full Width?	N/A
N/A	Landing Curb? (Y/N)	N/A	N/A	DWS Offset (in)	N/A
N/A	Shared Landing?	N/A			
N/A	Gutter Ponding?	N/A	N/A	Gutter Slope (%)	N/A
N/A	Gutter Lip Ht (in)	N/A	N/A	Gutter X Slope (%)	N/A
N/A	Painted X Walk1?	No	N/A	Painted X Walk2?	Yes
	X Walk 1 Direction	To NE		X Walk 2 Direction	To NW
N/A	X Walk 1 Width (in)	N/A	N/A	X Walk 2 Width (in)	143.0
	X Walk 1 Slope (%)	1.6		X Walk 2 Slope (%)	6.3
	X Walk 1 X Slope (%)	1.6		X Walk 2 X Slope (%)	0.1

N/A	Ramp inside XWalk1?	N/A	N/A	Ramp inside XWalk2?	Yes
	Road Slope (%)	1.7	N/A	Clear Space?	N/A
	Road X Slope (%)	1.5	N/A	Clear Space to XWalk (in)	N/A
N/A	Any Obstructions?	N/A	N/A	Storm Grate/Utility Hazard?	N/A
	Obstruction Type			Storm Grate/Utility Type	
		N/A			N/A
			Yes	Surface Condition? (G/P)	Good

Possible Solutions:

**Remove & Replace Curb Ramp With Two New Directional Ramps or Equivalent.**

**R304.2.2, R304.5.3**
