Access Compliance Report

Public Rights-of-Way

(Curb Ramps)

Intersection ID: 24524	Main Street: CELBRIDGE_CT	Cross Street: SAINTFIELD_PL	Location: SE
ADA ID: ACEED07E3FDD	Ramp Type: PerpDiag	Initial Pass/Fail: Fail	Overall Compliance: No
Severity Score: 12.5			
Codes/Mitigation Info/Possible Solution		Field Measurements/Component Compliance

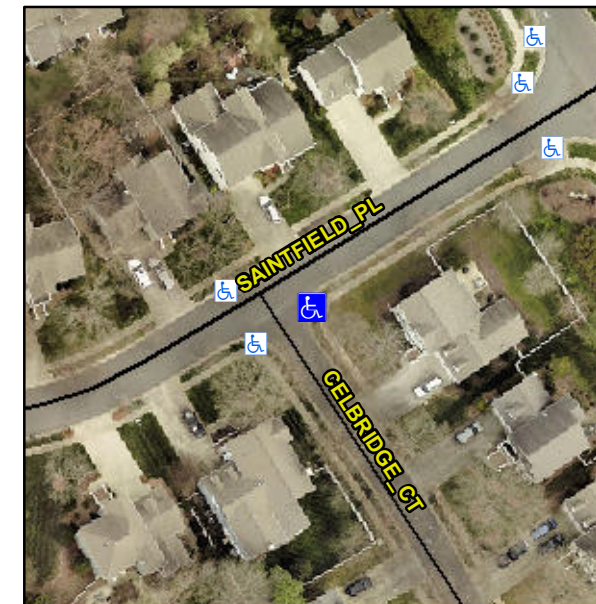
Not Found, R304.2.2

Compliance	Description	Data	Compliance	Description	Data
N/A	Ramp Length (in)	48.0	No	Ramp Slope (%)	10.6
Yes	Ramp Width (in)	48.0	Yes	Ramp XSlope (%)	1.4
N/A	Flare Type LT	N/A	N/A	Flare Type RT	N/A
N/A	Flare Slope LT (%)	N/A	N/A	Flare Slope RT (%)	N/A
N/A	Flare Traversable LT?	N/A	N/A	Flare Traversable RT?	N/A
N/A	Landing Length (in)	N/A	N/A	DWS Provided?	N/A
N/A	Landing Width (in)	N/A	N/A	DWS Contrast?	N/A
N/A	Landing Slope (%)	N/A	N/A	DWS Length (in)	N/A
N/A	Landing X Slope (%)	N/A	N/A	DWS Full Width?	N/A
N/A	Landing Curb? (Y/N)	N/A	N/A	DWS Offset (in)	N/A
N/A	Shared Landing?	N/A			
N/A	Gutter Ponding?	Yes	N/A	Gutter Slope (%)	N/A
N/A	Gutter Lip Ht (in)	N/A	N/A	Gutter X Slope (%)	N/A
N/A	Painted X Walk1?	No	N/A	Painted X Walk2?	No
	X Walk 1 Direction	To N		X Walk 2 Direction	To W
N/A	X Walk 1 Width (in)	N/A	N/A	X Walk 2 Width (in)	N/A
	X Walk 1 Slope (%)	6.0		X Walk 2 Slope (%)	0.7
	X Walk 1 X Slope (%)	1.2		X Walk 2 X Slope (%)	2.7

N/A	Ramp inside XWalk1?	N/A	N/A	Ramp inside XWalk2?	N/A
	Road Slope (%)	0.2	N/A	Clear Space?	N/A
	Road X Slope (%)	1.7	N/A	Clear Space to XWalk (in)	N/A
N/A	Any Obstructions?	N/A	N/A	Storm Grate/Utility Hazard?	N/A
	Obstruction Type			Storm Grate/Utility Type	
		N/A			N/A
		Yes		Surface Condition? (G/P)	Good

Remove & Replace Curb Ramp With Two New Directional Ramps or Equivalent.
