Access Compliance Report Public Rights-of-Way (Curb Ramps)

Intersection ID: 12076 Main Street: N_CHURCH_ST Cross Street: W_5TH_ST Location: S

ADA ID: ACF61FA336B2 Ramp Type: PerpDiag Initial Pass/Fail: Pass Overall Compliance: No Severity Score: 10

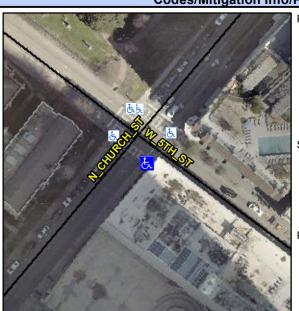
Not Found, R304.2.1, R304.2.2-Perp, R304.3.2-Para, R304.5.3

Yes	Ramp inside XWalk1?	Yes	Yes	Ramp inside XWalk2?	Yes
	Road Slope (%)	4.1	N/A	Clear Space?	No
	Road X Slope (%)	0.7	No	Clear Space to XWalk (in)	N/A

Remove & Replace Curb Ramp With Two New Directional Ramps or Equivalent. Restripe Crosswalk(s) To Provide Clear space.
