# Access Compliance Report

## Public Rights-of-Way

### (Curb Ramps)

Intersection ID: 46730	Main Street: HAMILTON_FOREST_DR	Cross Street: RUSTIC_VIEW_CT	Location: SE
ADA ID: AD00E010A87A	Ramp Type: PerpDiag	Initial Pass/Fail: Fail	Overall Compliance: No
			Severity Score: 33.75

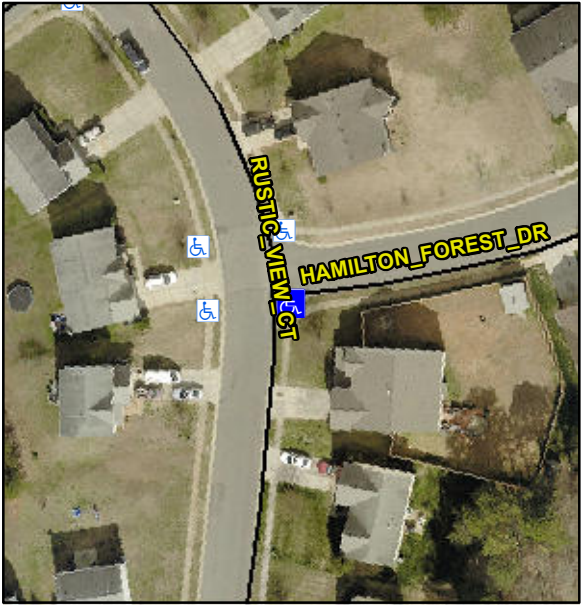
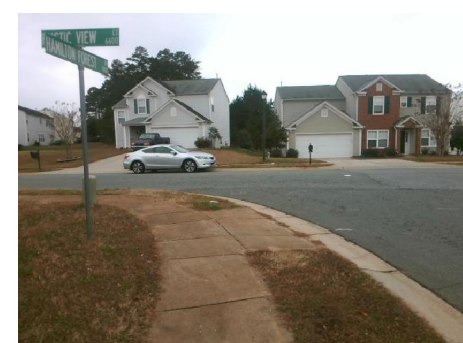
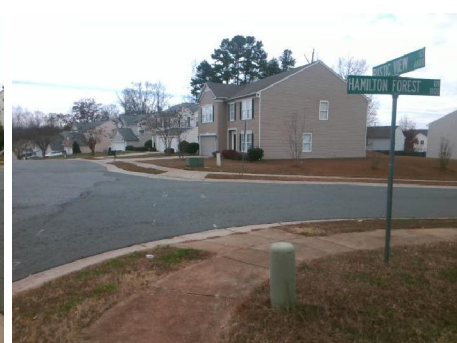
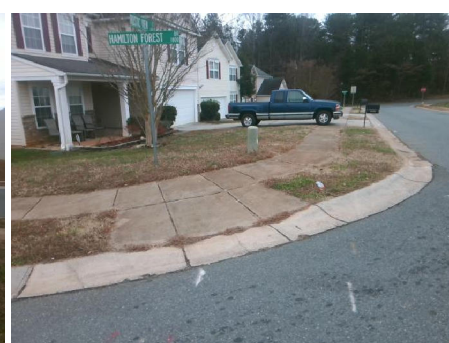
Possible Solutions:		<b>Compliance</b>	<b>Description</b>	<b>Data</b>
	<b>Remove &amp; Replace Curb Ramp With Two New Directional Ramps or Equivalent.</b>		<b>No</b>	Ramp Length (in)	48.0
			<b>No</b>	Ramp Width (in)	39.0
			<b>N/A</b>	Flare Type LT	N/A
			<b>N/A</b>	Flare Slope LT (%)	N/A
			<b>N/A</b>	Flare Traversable LT?	N/A
			<b>N/A</b>	Landing Length (in)	N/A
			<b>N/A</b>	Landing Width (in)	N/A
			<b>N/A</b>	Landing Slope (%)	N/A
			<b>N/A</b>	Landing X Slope (%)	N/A
			<b>N/A</b>	Landing Curb? (Y/N)	N/A
			<b>N/A</b>	Shared Landing?	N/A
			<b>N/A</b>	Gutter Ponding?	N/A
			<b>N/A</b>	Gutter Lip Ht (in)	N/A
			<b>N/A</b>	Painted X Walk1?	No
				X Walk 1 Direction	To W
			<b>N/A</b>	X Walk 1 Width (in)	N/A
				X Walk 1 Slope (%)	2.5
				X Walk 1 X Slope (%)	5.2
			<b>N/A</b>	Ramp inside XWalk1?	N/A
<p>Surveyor Notes:</p> <p><b>N/A</b></p> <p>PROW/ADA:</p> <p><b>Not Found, R304.5.1, R304.2.2, R304.5.3</b></p>			<b>N/A</b>	Ramp Slope (%)	11.3

<b>No</b>	Ramp XSlope (%)	6.6
			<b>N/A</b>	Flare Type RT	N/A
			<b>N/A</b>	Flare Slope RT (%)	N/A
			<b>N/A</b>	Flare Traversable RT?	N/A
			<b>N/A</b>	DWS Provided?	N/A
			<b>N/A</b>	DWS Contrast?	N/A
			<b>N/A</b>	DWS Length (in)	N/A
			<b>N/A</b>	DWS Full Width?	N/A
			<b>N/A</b>	DWS Offset (in)	N/A
			<b>N/A</b>	Gutter Slope (%)	N/A
			<b>N/A</b>	Gutter X Slope (%)	N/A
			<b>N/A</b>	Painted X Walk2?	No
				X Walk 2 Direction	To N
			<b>N/A</b>	X Walk 2 Width (in)	N/A
				X Walk 2 Slope (%)	3.0
				X Walk 2 X Slope (%)	0.9
			<b>N/A</b>	Ramp inside XWalk2?	N/A
			<b>N/A</b>	Clear Space?	N/A
			<b>N/A</b>	Clear Space to XWalk (in)	N/A
<p>Total Cost:</p> <p>\$ 3200.00</p>			<b>N/A</b>	Storm Grate/Utility Hazard?	N/A
				Storm Grate/Utility Type	
			<b>N/A</b>		N/A
			<b>Yes</b>	Surface Condition? (G/P)	Good
