# Access Compliance Report

## Public Rights-of-Way

| Intersection ID: 44008 | Main Street: ARCOLA_LN | Cross Street: DEMAINE_DR | Location: W |
| ADA ID: AD12E5C79ECF | Ramp Type: BlendTrans1 | Initial Pass/Fail: Pass | Overall Compliance: No |

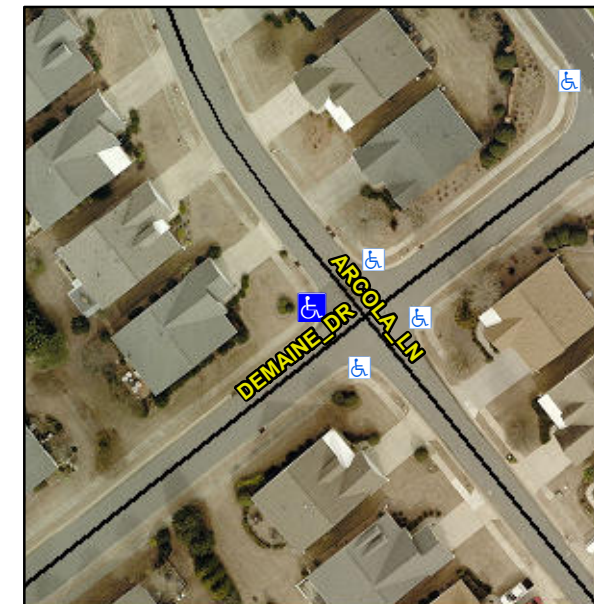
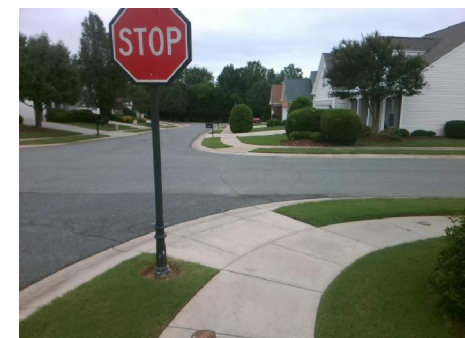
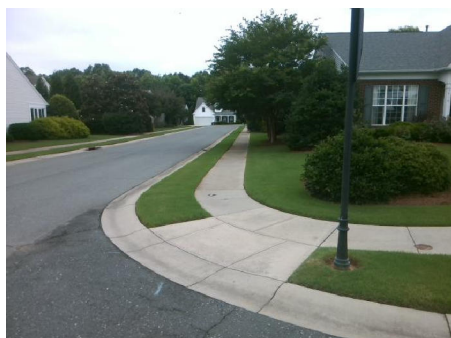
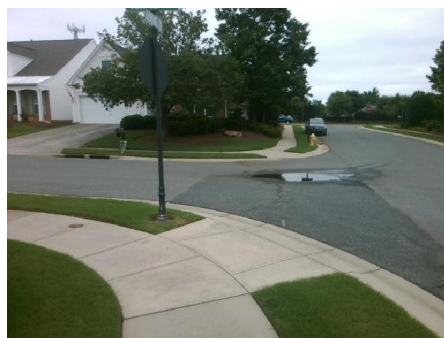
| Severity Score: 22.75 | | | |

**Not Found, R304.5.3, R304.2.1, R305, R302.7.2, R304.5.4**

| Compliance | Description | Data | Compliance | Description | Data |
|---|---|---|---|---|---|
| Yes | Ramp Width (in) | 52.0 | No | BlendTrans XSlope (%) | 2.7 |
| No | Landing Length (in) | 47.0 | No | DWS Provided? | No |
| Yes | Gutter Ponding? | No | No | Gutter Slope (%) | 7.8 |
| No | Gutter Lip Ht (in) | 0.3 | Yes | Gutter X Slope (%) | 0.9 |
| | | | No | Curb Slope (%) | 5.2 |

**Remove & Replace Curb Ramp With Two New Directional Ramps or Equivalent. Remove & Replace Gutter.**

Total Cost: \$ 3950.00
