Access Compliance Report

Public Rights-of-Way (Curb Ramps)

Intersection ID: 10252		Main Street: MATHIS_DR		Cross Street: ROGERS_ST		Location: E											
ADA ID: AD17C17B1271		Ramp Type: Directional1		Initial Pass/Fail: Pass		Overall Compliance: No		Severity Score: 2.5									
Codes/Mitigation Info/Possible Solution				Field Measurements/Component Compliance													
<div>

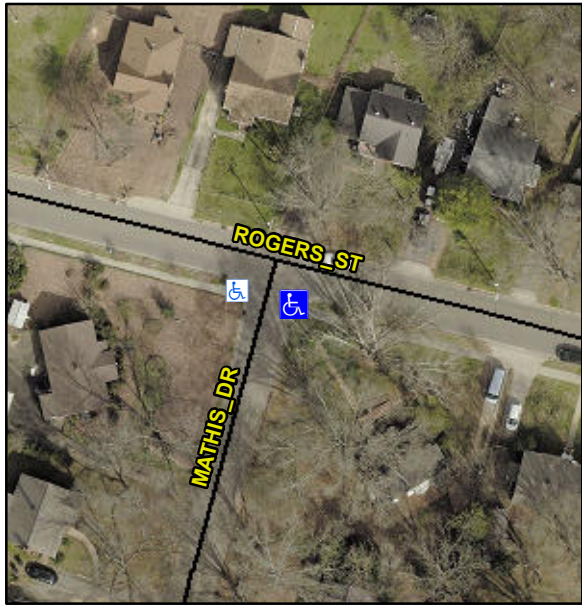
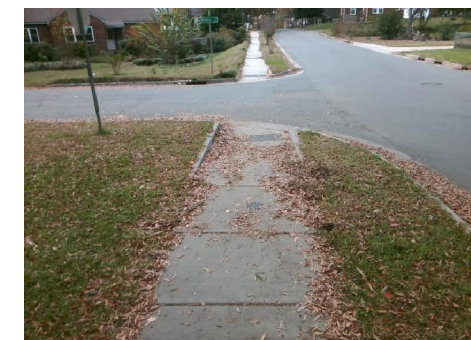
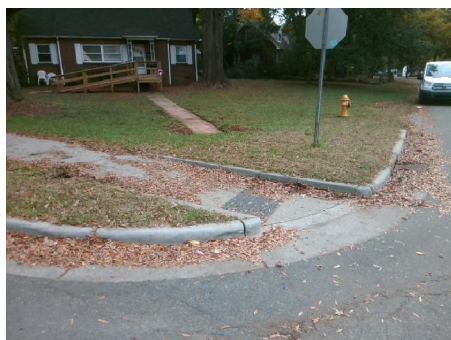
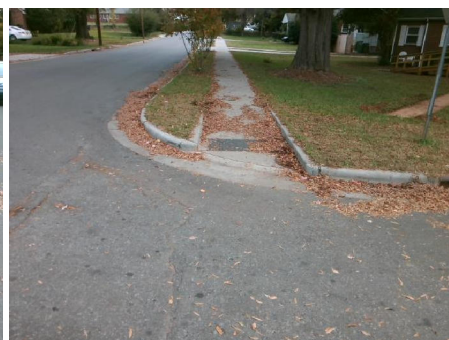
Yes		Ramp Width (in)		58.5		No		Grade Break Slope (%)		5.6			
				Yes		Ramp Slope (%)		6.4		Yes		Grade Break XSlope (%)		1.0			
				Yes		Ramp XSlope (%)		1.0									
				Yes		Flare Type LT		N/A		Yes		Flare Type RT		N/A			
				N/A		Flare Slope LT (%)		N/A		N/A		Flare Slope RT (%)		N/A			
				N/A		Flare Traversable LT?		No		N/A		Flare Traversable RT?		No			
				No		Landing Length (in)		45.0		Yes		DWS Provided?		Yes			
				Yes		Landing Width (in)		60.0		Yes		DWS Contrast?		Yes			
				No		Landing Slope (%)		2.9		Yes		DWS Length (in)		24.0			
				Yes		Landing X Slope (%)		1.4		No		DWS Full Width?		No			
				N/A		Landing Curb? (Y/N)		N/A		No		DWS Offset LT (in)		5.0			
				N/A		Shared Landing?		No		Yes		DWS Offset RT (in)		31.0			
				Yes		Gutter Ponding?		No		Yes		Gutter Slope (%)		2.6			
				Yes		Gutter Lip Ht (in)		0.0		Yes		Gutter X Slope (%)		1.2			
				N/A		Painted X Walk1?		No				Road Slope (%)		1.7

X Walk 1 Direction		To NW				Road X Slope (%)		3.2			
						X Walk 1 Width (in)		N/A				Clear Space?		Yes			
						X Walk 1 Slope (%)		1.7		N/A		Clear Space to XWalk (in)		N/A			
						X Walk 1 X Slope (%)		3.2		Yes		Storm Grate/Utility Hazard?		No			
				N/A		Ramp inside XWalk1?		N/A				Storm Grate/Utility Type					
				Yes		Any Obstructions?		No						N/A			
						Obstruction Type				Yes		Surface Condition? (G/P)		Good			
										N/A		No		Curb Slope (%)		8.6

</div> <div>Possible Solutions:</div> <div>Remove & Replace Entire Ramp.</div> <div>Surveyor Notes:</div> <div>N/A</div> <div>PROW/ADA:</div> <div>Not Found, R304.2.1, R304.2.2-Perp, R304.3.2-Para, R304.5.3, R305.1.4, R305.2</div> <div>Street 1 Name</div> <div>MATHIS DR</div> <div>Stop Condition-Street 1</div> <div>StopSign</div> <div>Street 2 Name</div> <div>N/A</div> <div>Stop Condition-Street 2</div> <div>N/A</div> <div>Total Cost:</div> <div>\$</div> <div>1600.00</div>				Compliance		Description		Data		Compliance		Description		Data			
				N/A		Ramp Length (in)		127.0		Yes		Grade Break?		Yes
