# Access Compliance Report

## Public Rights-of-Way

### (Curb Ramps)

Intersection ID: 18671	Main Street: BAKER_DR	Cross Street: SENECA_PL	Location: SE
ADA ID: AD1D33A229A5	Ramp Type: PerpDiag	Initial Pass/Fail: Fail	Overall Compliance: No
		Severity Score: 10

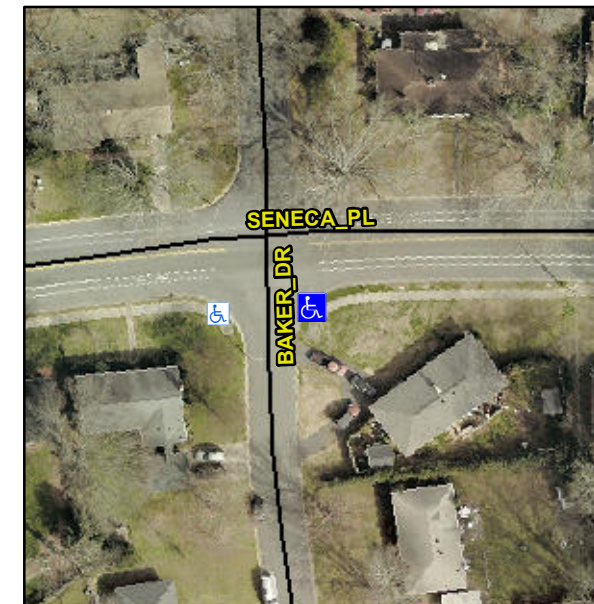
Compliance	Description	Data	Compliance	Description	Data
N/A	Ramp Length (in)	49.0	Yes	Ramp Slope (%)	6.9
No	Ramp Width (in)	47.0	No	Ramp XSlope (%)	3.0
N/A	Flare Type LT	N/A	N/A	Flare Type RT	N/A
N/A	Flare Slope LT (%)	N/A	N/A	Flare Slope RT (%)	N/A
N/A	Flare Traversable LT?	N/A	N/A	Flare Traversable RT?	N/A
N/A	Landing Length (in)	N/A	N/A	DWS Provided?	N/A
N/A	Landing Width (in)	N/A	N/A	DWS Contrast?	N/A
N/A	Landing Slope (%)	N/A	N/A	DWS Length (in)	N/A
N/A	Landing X Slope (%)	N/A	N/A	DWS Full Width?	N/A
N/A	Landing Curb? (Y/N)	N/A	N/A	DWS Offset (in)	N/A
N/A	Shared Landing?	N/A			
N/A	Gutter Ponding?	N/A	N/A	Gutter Slope (%)	N/A
N/A	Gutter Lip Ht (in)	N/A	N/A	Gutter X Slope (%)	N/A
N/A	Painted X Walk1?	No	N/A	Painted X Walk2?	No
	X Walk 1 Direction	To N		X Walk 2 Direction	To W
N/A	X Walk 1 Width (in)	N/A	N/A	X Walk 2 Width (in)	N/A
	X Walk 1 Slope (%)	3.1		X Walk 2 Slope (%)	5.6
	X Walk 1 X Slope (%)	2.4		X Walk 2 X Slope (%)	2.7

N/A	Ramp inside XWalk1?	N/A	N/A	Ramp inside XWalk2?	N/A
	Road Slope (%)	1.0	N/A	Clear Space?	N/A
	Road X Slope (%)	5.2	N/A	Clear Space to XWalk (in)	N/A
N/A	Any Obstructions?	N/A	N/A	Storm Grate/Utility Hazard?	N/A
	Obstruction Type			Storm Grate/Utility Type	
		N/A			N/A
		Yes		Surface Condition? (G/P)	Good

**Remove & Replace Curb Ramp With Two New Directional Ramps or Equivalent.**

**R304.5.1, R304.5.3**
