Access Compliance Report

Public Rights-of-Way

(Curb Ramps)

Intersection ID: 21535	Main Street: WOODSTOCK_DR	Cross Street: WOODSTREAM_DR	Location: W
ADA ID: AD216D7B2221	Ramp Type: PerpDiag	Initial Pass/Fail: Fail	Overall Compliance: No
			Severity Score: 13.75

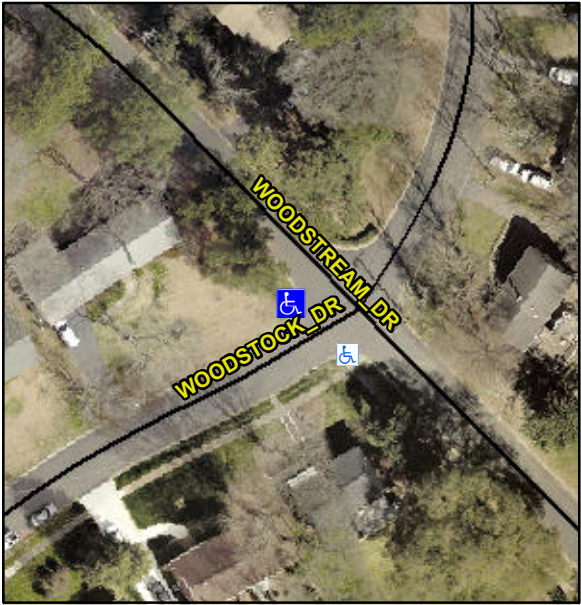
Possible Solutions:		Compliance	Description	Data
	Remove & Replace Curb Ramp With Two New Directional Ramps or Equivalent.		N/A	Ramp Length (in)	49.0
			Yes	Ramp Width (in)	48.0
			N/A	Flare Type LT	N/A
			N/A	Flare Slope LT (%)	N/A
			N/A	Flare Traversable LT?	N/A
			N/A	Landing Length (in)	N/A
			N/A	Landing Width (in)	N/A
			N/A	Landing Slope (%)	N/A
			N/A	Landing X Slope (%)	N/A
<p>Surveyor Notes:</p> <p>N/A</p> <p>PROW/ADA:</p> <p>Not Found, R304.2.2, R304.5.3</p>			N/A	Flare Type RT	N/A
			N/A	Flare Slope RT (%)	N/A
			N/A	Flare Traversable RT?	N/A
			N/A	DWS Provided?	N/A
			N/A	DWS Contrast?	N/A
			N/A	DWS Length (in)	N/A
			N/A	DWS Full Width?	N/A
			N/A	DWS Offset (in)	N/A
			N/A	Gutter Ponding?	N/A
			N/A	Gutter Lip Ht (in)	N/A
			N/A	Painted X Walk1?	No
				X Walk 1 Direction	To NE
			N/A	X Walk 1 Width (in)	N/A

X Walk 1 Slope (%)	2.1
				X Walk 1 X Slope (%)	0.1
			N/A	Ramp inside XWalk1?	N/A
				Road Slope (%)	0.4
				Road X Slope (%)	0.2
			N/A	Any Obstructions?	N/A
				Obstruction Type	
Total Cost:		\$ 3200.00			
			N/A		N/A
			Yes	Surface Condition? (G/P)	Good
