# Access Compliance Report

## Public Rights-of-Way

### (Curb Ramps)

| Intersection ID: 17772 | Main Street: IDLEWILD_RD | Cross Street: VALLEY_GROVE_RD | Location: SE |

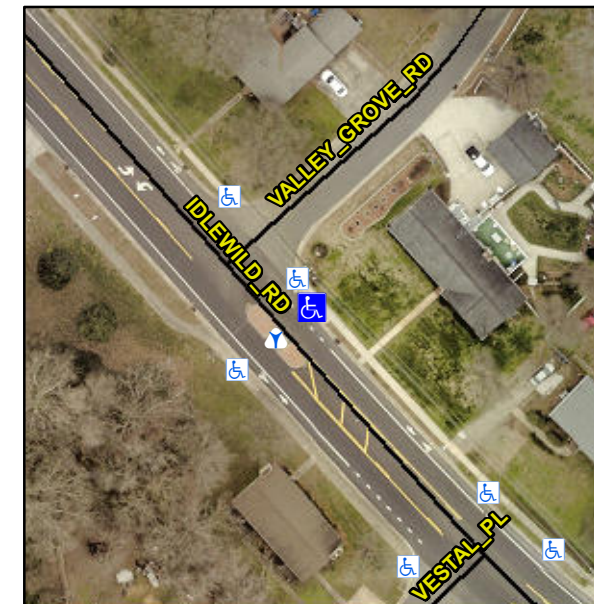
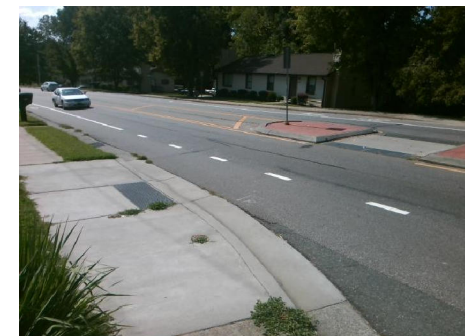
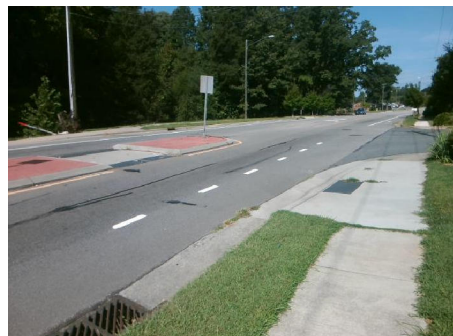
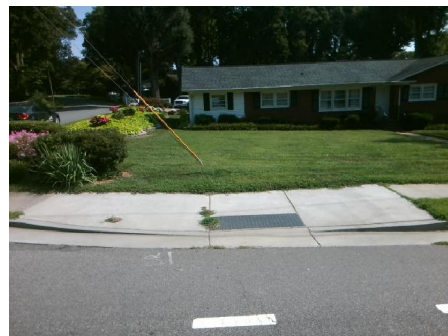
| ADA ID: AD249F8327E8 | Ramp Type: BlendTrans2 | Initial Pass/Fail: Pass | Overall Compliance: No |
| Severity Score: 5.25 | | | |

**Not Found, R304.5.4**

| Compliance | Description | Data | Compliance | Description | Data |
|---|---|---|---|---|---|
| Yes | Gutter Ponding? | No | No | Gutter Slope (%) | 9.5 |
| | | | No | Curb Slope (%) | 7.4 |

**Remove & Replace Curb Slope and Extend Ramp. Remove & Replace Gutter.**

Total Cost: \$ 2750.00
