Access Compliance Report

Public Rights-of-Way

(Curb Ramps)

| Intersection ID: 53235 | Main Street: EVERGREEN_DR | Cross Street: DOLLY_MADISON_RD | Location: NE |

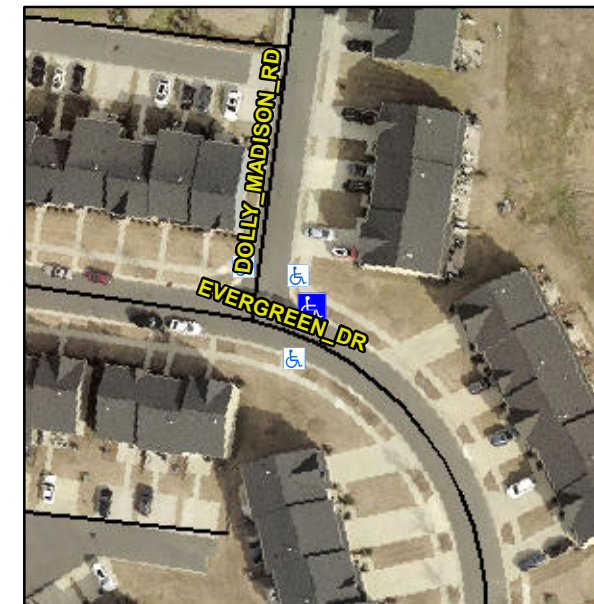
| ADA ID: AD29C89B376B | Ramp Type: Perp | Initial Pass/Fail: Fail | Overall Compliance: No |
| | | Severity Score: 22.5 | |

R304.5.1, R304.2.2

| Compliance | Description | Data | Compliance | Description | Data |
|---|---|---|---|---|---|
| N/A | Ramp Length (in) | 66.0 | No | Ramp Slope (%) | 8.5 |
| No | Ramp Width (in) | 47.5 | Yes | Ramp XSlope (%) | 2.2 |

Possible Solutions:

Remove & Replace Entire Ramp.

Total Cost: \$ 1850.00
