# Access Compliance Report

## Public Rights-of-Way

| Intersection ID: 15916 | Main Street: BRANDON_RD | Cross Street: PEMBROKE_AV | Location: N |
| ADA ID: AD301EDF9A42 | Ramp Type: BlendTrans1 | Initial Pass/Fail: Pass | Overall Compliance: No |

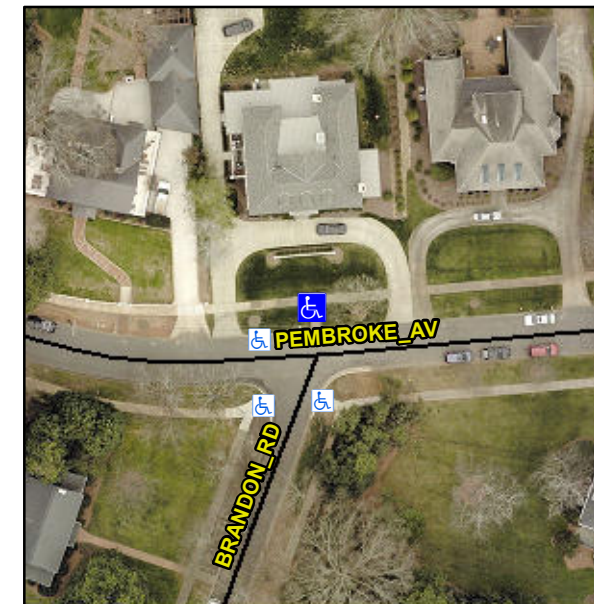
**Not Found, R304.2.2-Perp, R304.3.2-Para, R305, R302.7.2, R304.5.4**

| Compliance | Description | Data | Compliance | Description | Data |
|---|---|---|---|---|---|
| Yes | Landing Length (in) | 64.0 | No | DWS Provided? | No |
| No | Landing Slope (%) | 5.4 | N/A | DWS Length (in) | N/A |
| Yes | Gutter Ponding? | No | No | Gutter Slope (%) | 5.7 |
| No | Gutter Lip Ht (in) | 1.0 | Yes | Gutter X Slope (%) | 3.8 |
| | | | No | Curb Slope (%) | 15.0 |

**Remove & Replace Curb Ramp With Two New Directional Ramps or Equivalent. Remove & Replace Gutter.**
