# Access Compliance Report

## Public Rights-of-Way

### (Curb Ramps)

Intersection ID: 18541	Main Street: PROVIDENCE_RD	Cross Street: WESTBURY_RD	Location: E
ADA ID: AD34AF74F16E	Ramp Type: PerpDiag	Initial Pass/Fail: Fail	Overall Compliance: No
Severity Score: 8.75			
Codes/Mitigation Info/Possible Solution		Field Measurements/Component Compliance

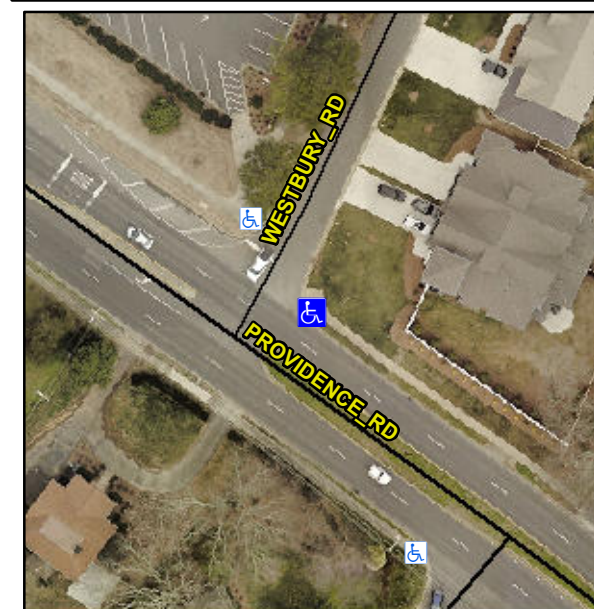
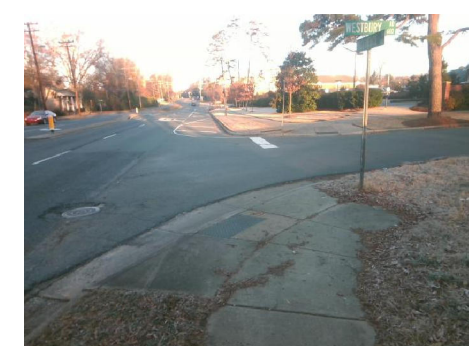
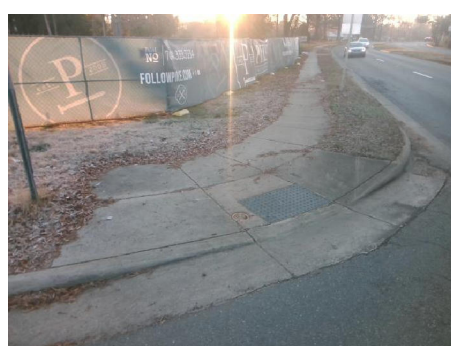
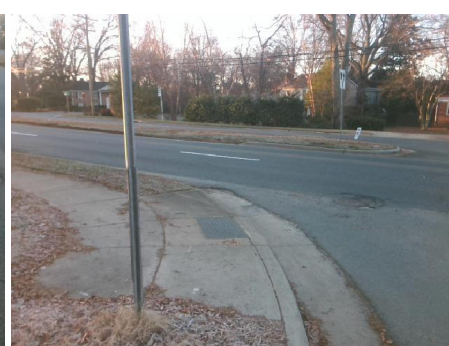
**Not Found, R304.5.1**

Compliance	Description	Data	Compliance	Description	Data
N/A	Ramp Length (in)	45.0	Yes	Ramp Slope (%)	6.9
No	Ramp Width (in)	42.0	Yes	Ramp XSlope (%)	1.9
N/A	Flare Type LT	N/A	N/A	Flare Type RT	N/A
N/A	Flare Slope LT (%)	N/A	N/A	Flare Slope RT (%)	N/A
N/A	Flare Traversable LT?	N/A	N/A	Flare Traversable RT?	N/A
N/A	Landing Length (in)	N/A	N/A	DWS Provided?	N/A
N/A	Landing Width (in)	N/A	N/A	DWS Contrast?	N/A
N/A	Landing Slope (%)	N/A	N/A	DWS Length (in)	N/A
N/A	Landing X Slope (%)	N/A	N/A	DWS Full Width?	N/A
N/A	Landing Curb? (Y/N)	N/A	N/A	DWS Offset (in)	N/A
N/A	Shared Landing?	N/A			
N/A	Gutter Ponding?	N/A	N/A	Gutter Slope (%)	N/A
N/A	Gutter Lip Ht (in)	N/A	N/A	Gutter X Slope (%)	N/A
N/A	Painted X Walk1?	No	N/A	Painted X Walk2?	No
	X Walk 1 Direction	To NW		X Walk 2 Direction	To SW
N/A	X Walk 1 Width (in)	N/A	N/A	X Walk 2 Width (in)	N/A
	X Walk 1 Slope (%)	2.1		X Walk 2 Slope (%)	1.2
	X Walk 1 X Slope (%)	0.3		X Walk 2 X Slope (%)	3.4

N/A	Ramp inside XWalk1?	N/A	N/A	Ramp inside XWalk2?	N/A
	Road Slope (%)	3.6	N/A	Clear Space?	N/A
	Road X Slope (%)	2.0	N/A	Clear Space to XWalk (in)	N/A
N/A	Any Obstructions?	N/A	N/A	Storm Grate/Utility Hazard?	N/A
	Obstruction Type			Storm Grate/Utility Type	
		N/A			N/A
		Yes		Surface Condition? (G/P)	Good

**Remove & Replace Curb Ramp With Two New Directional Ramps or Equivalent.**
