Access Compliance Report

Public Rights-of-Way

(Curb Ramps)

Intersection ID: 30475	Main Street: PLANTERS_ROW_DR	Cross Street: WALKING_STICK_DR	Location: SE
ADA ID: AD46F82E4CD2	Ramp Type: PerpDiag	Initial Pass/Fail: Fail	Overall Compliance: No
Codes/Mitigation Info/Possible Solution			Severity Score: 10
			Field Measurements/Component Compliance

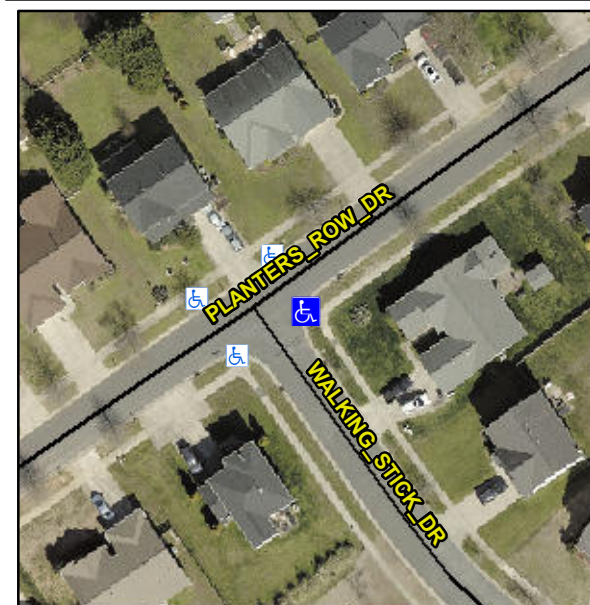
Not Found, R304.5.1, R304.5.3

Compliance	Description	Data	Compliance	Description	Data
N/A	Ramp Length (in)	83.0	Yes	Ramp Slope (%)	6.4
No	Ramp Width (in)	47.0	No	Ramp XSlope (%)	3.3
N/A	Flare Type LT	N/A	N/A	Flare Type RT	N/A
N/A	Flare Slope LT (%)	N/A	N/A	Flare Slope RT (%)	N/A
N/A	Flare Traversable LT?	N/A	N/A	Flare Traversable RT?	N/A
N/A	Landing Length (in)	N/A	N/A	DWS Provided?	N/A
N/A	Landing Width (in)	N/A	N/A	DWS Contrast?	N/A
N/A	Landing Slope (%)	N/A	N/A	DWS Length (in)	N/A
N/A	Landing X Slope (%)	N/A	N/A	DWS Full Width?	N/A
N/A	Landing Curb? (Y/N)	N/A	N/A	DWS Offset (in)	N/A
N/A	Shared Landing?	N/A			
N/A	Gutter Ponding?	N/A	N/A	Gutter Slope (%)	N/A
N/A	Gutter Lip Ht (in)	N/A	N/A	Gutter X Slope (%)	N/A
N/A	Painted X Walk1?	No	N/A	Painted X Walk2?	No
	X Walk 1 Direction	To NW		X Walk 2 Direction	To SW
N/A	X Walk 1 Width (in)	N/A	N/A	X Walk 2 Width (in)	N/A
	X Walk 1 Slope (%)	0.2		X Walk 2 Slope (%)	3.3
	X Walk 1 X Slope (%)	3.7		X Walk 2 X Slope (%)	0.7

N/A	Ramp inside XWalk1?	N/A	N/A	Ramp inside XWalk2?	N/A
	Road Slope (%)	2.4	N/A	Clear Space?	N/A
	Road X Slope (%)	5.0	N/A	Clear Space to XWalk (in)	N/A
N/A	Any Obstructions?	N/A	N/A	Storm Grate/Utility Hazard?	N/A
	Obstruction Type			Storm Grate/Utility Type	
		N/A			N/A
			Yes	Surface Condition? (G/P)	Good

Remove & Replace Curb Ramp With Two New Directional Ramps or Equivalent.
