# Access Compliance Report

## Public Rights-of-Way

### (Curb Ramps)

Intersection ID: 6988	Main Street: DEERWOOD_RD	Cross Street: TILDEN_RD	Location: SW
ADA ID: AD4FAD234CF6	Ramp Type: Perp	Initial Pass/Fail: Fail	Overall Compliance: No
Severity Score: 22.5			
Codes/Mitigation Info/Possible Solution		Field Measurements/Component Compliance

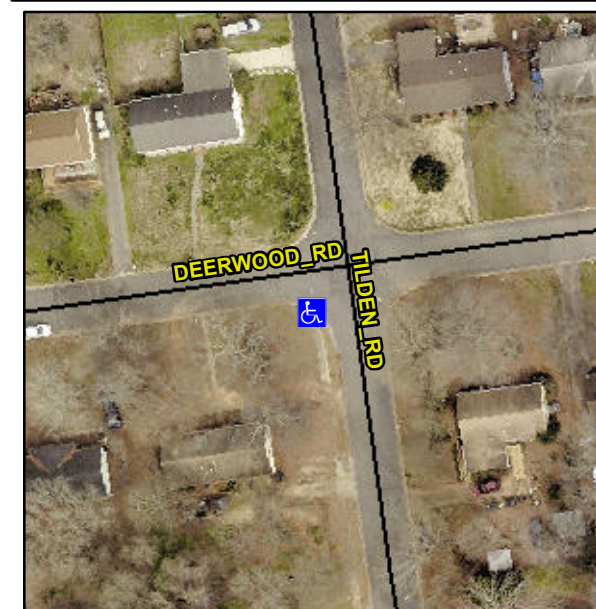
Compliance	Description	Data	Compliance	Description	Data
N/A	Ramp Length (in)	43.0	No	Ramp Slope (%)	8.6
No	Ramp Width (in)	37.0	No	Ramp XSlope (%)	2.5
N/A	Flare Type LT	N/A	N/A	Flare Type RT	N/A
N/A	Flare Slope LT (%)	N/A	N/A	Flare Slope RT (%)	N/A
N/A	Flare Traversable LT?	N/A	N/A	Flare Traversable RT?	N/A
N/A	Landing Length (in)	N/A	N/A	DWS Provided?	N/A
N/A	Landing Width (in)	N/A	N/A	DWS Contrast?	N/A
N/A	Landing Slope (%)	N/A	N/A	DWS Length (in)	N/A
N/A	Landing X Slope (%)	N/A	N/A	DWS Full Width?	N/A
N/A	Landing Curb? (Y/N)	N/A	N/A	DWS Offset (in)	N/A
N/A	Shared Landing?	N/A			
N/A	Gutter Ponding?	N/A	N/A	Gutter Slope (%)	N/A
N/A	Gutter Lip Ht (in)	N/A	N/A	Gutter X Slope (%)	N/A
N/A	Painted X Walk1?	No	N/A	Painted X Walk2?	N/A
	X Walk 1 Direction	To E		X Walk 2 Direction	N/A
N/A	X Walk 1 Width (in)	N/A	N/A	X Walk 2 Width (in)	N/A
	X Walk 1 Slope (%)	6.7		X Walk 2 Slope (%)	N/A
	X Walk 1 X Slope (%)	2.0		X Walk 2 X Slope (%)	N/A

N/A	Ramp inside XWalk1?	N/A	N/A	Ramp inside XWalk2?	N/A
	Road Slope (%)	2.0	N/A	Clear Space?	N/A
	Road X Slope (%)	6.7	N/A	Clear Space to XWalk (in)	N/A
N/A	Any Obstructions?	N/A	N/A	Storm Grate/Utility Hazard?	N/A
	Obstruction Type			Storm Grate/Utility Type	
		N/A			N/A
			Yes	Surface Condition? (G/P)	Good

Possible Solutions:

**Remove & Replace Entire Ramp.**

**R304.5.1, R304.2.2, R304.5.3**
