Access Compliance Report Public Rights-of-Way (Curb Ramps)

Intersection ID: 10033988	Main Street: PARK_RD	Cross Street: N/A	Location: W
ADA ID: AD51C10D9FFA	Ramp Type: Directional2	Initial Pass/Fail: Fail	Overall Compliance: No Severity Score: 1.25

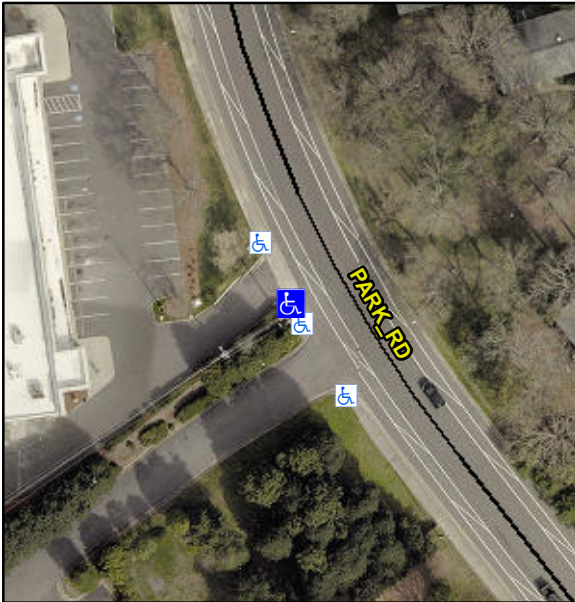
Compliance	Description	Data	Compliance	Description	Data
N/A	Ramp Length (in)	54.0	N/A	Grade Break?	N/A
Yes	Ramp Width (in)	48.0	N/A	Grade Break Slope (%)	0.0
Yes	Ramp Slope (%)	6.3	N/A	Grade Break XSlope (%)	0.0
No	Ramp XSlope (%)	3.9			
N/A	Flare Type LT	N/A	N/A	Flare Type RT	N/A
N/A	Flare Slope LT (%)	N/A	N/A	Flare Slope RT (%)	0.0
N/A	Flare Traversable LT?	N/A	N/A	Flare Traversable RT?	N/A
N/A	Landing Length (in)	0.0	N/A	DWS Provided?	N/A
N/A	Landing Width (in)	0.0	N/A	DWS Contrast?	N/A
N/A	Landing Slope (%)	0.0	N/A	DWS Length (in)	N/A
N/A	Landing X Slope (%)	0.0	N/A	DWS Full Width?	N/A
N/A	Landing Curb? (Y/N)	N/A	N/A	DWS Offset LT (in)	N/A
N/A	Shared Landing?	N/A	N/A	DWS Offset RT (in)	N/A
N/A	Gutter Ponding?	0.0	N/A	Gutter Slope (%)	N/A
N/A	Gutter Lip Ht (in)	0.0	N/A	Gutter X Slope (%)	N/A
N/A	Painted X Walk1?	No		Road Slope (%)	1.3
	X Walk 1 Direction	To NW		Road X Slope (%)	3.9
	X Walk 1 Width (in)	N/A		Clear Space?	N/A

X Walk 1 Slope (%)	1.3	N/A	Clear Space to XWalk (in)	N/A
	X Walk 1 X Slope (%)	3.9	N/A	Storm Grate/Utility Hazard?	N/A
N/A	Ramp inside XWalk1?	N/A		Storm Grate/Utility Type	
N/A	Any Obstructions?	N/A			N/A
	Obstruction Type		Yes	Surface Condition? (G/P)	Good
			N/A	Curb Slope (%)	6.0

Possible Solutions:

Remove & Replace Entire Ramp.

R304.5.3
