Access Compliance Report

Public Rights-of-Way

(Curb Ramps)

Intersection ID: 27847	Main Street: PARADISE RIDGE RD	Cross Street: NORTH COMMUNITY HOUSE RD	Location: SE
ADA ID: AD56A493C257	Ramp Type: BlendTrans2	Initial Pass/Fail: Pass	Overall Compliance: No
Severity Score: 0.25			
Codes/Mitigation Info/Possible Solution		Field Measurements/Component Compliance

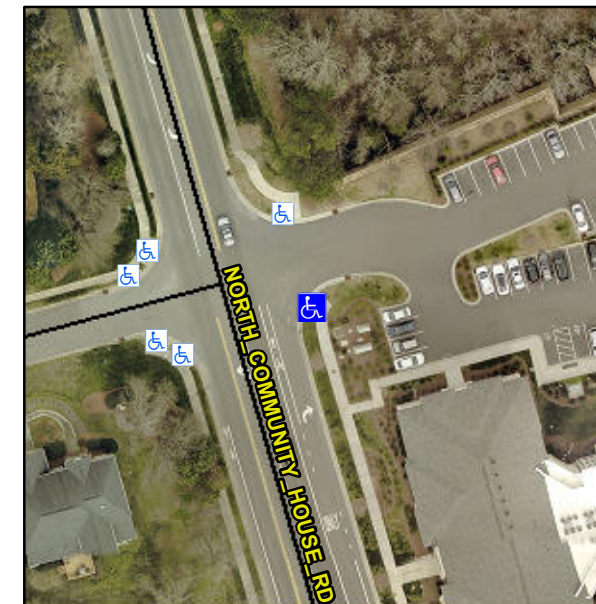
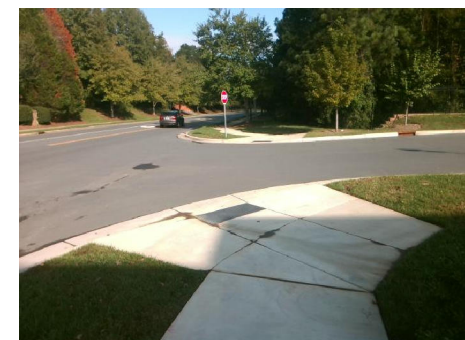
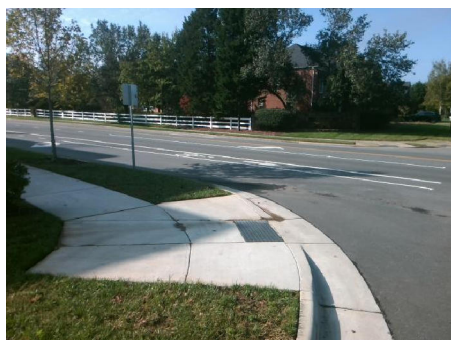
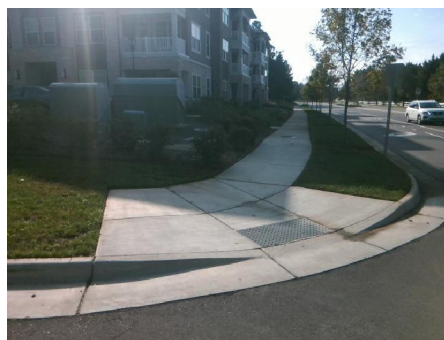
Compliance	Description	Data	Compliance	Description	Data
N/A	Ramp Length (in)	134.0	Yes	BlendTrans Slope (%)	3.3
Yes	Ramp Width (in)	48.0	No	BlendTrans XSlope (%)	2.4
N/A	Flare Type LT	Sloped	N/A	Flare Type RT	Sloped
N/A	Flare Slope LT (%)	N/A	N/A	Flare Slope RT (%)	N/A
N/A	Flare Traversable LT?	No	N/A	Flare Traversable RT?	No
N/A	Landing Length (in)	N/A	Yes	DWS Provided?	Yes
N/A	Landing Width (in)	N/A	Yes	DWS Contrast?	Yes
N/A	Landing Slope (%)	N/A	Yes	DWS Length (in)	24.0
N/A	Landing X Slope (%)	N/A	Yes	DWS Full Width?	Yes
N/A	Landing Curb? (Y/N)	No	Yes	DWS Offset (in)	1.0
N/A	Shared Landing?	No			
Yes	Gutter Ponding?	No	Yes	Gutter Slope (%)	2.8
Yes	Gutter Lip Ht (in)	0.0	Yes	Gutter X Slope (%)	1.7
N/A	Painted X Walk1?	No	N/A	Painted X Walk2?	No
	X Walk 1 Direction	To NE		X Walk 2 Direction	To NW
	X Walk 1 Width (in)	N/A		X Walk 2 Width (in)	N/A
	X Walk 1 Slope (%)	3.2		X Walk 2 Slope (%)	2.3
	X Walk 1 X Slope (%)	4.3		X Walk 2 X Slope (%)	1.6

N/A	Ramp inside XWalk1?	N/A	N/A	Ramp inside XWalk2?	N/A
	Road Slope (%)	3.2		Clear Space?	Yes
	Road X Slope (%)	4.4	N/A	Clear Space to XWalk (in)	N/A
Yes	Any Obstructions?	No	Yes	Storm Grate/Utility Hazard?	No
	Obstruction Type			Storm Grate/Utility Type	
		N/A			N/A
			Yes	Surface Condition? (G/P)	Good
			N/A	Curb Slope (%)	0.4

Possible Solutions:

Remove & Replace Curb Ramp With Two New Directional Ramps or Equivalent.

R304.5.3

Total Cost: \$ 3200.00
