Access Compliance Report

Public Rights-of-Way

(Curb Ramps)

Intersection ID: 48198	Main Street: RIVERGATE_PY	Cross Street: S_TRYON_ST	Location: SE
ADA ID: AD5A703AE585	Ramp Type: Perp	Initial Pass/Fail: Fail	Overall Compliance: No
		Severity Score: 10

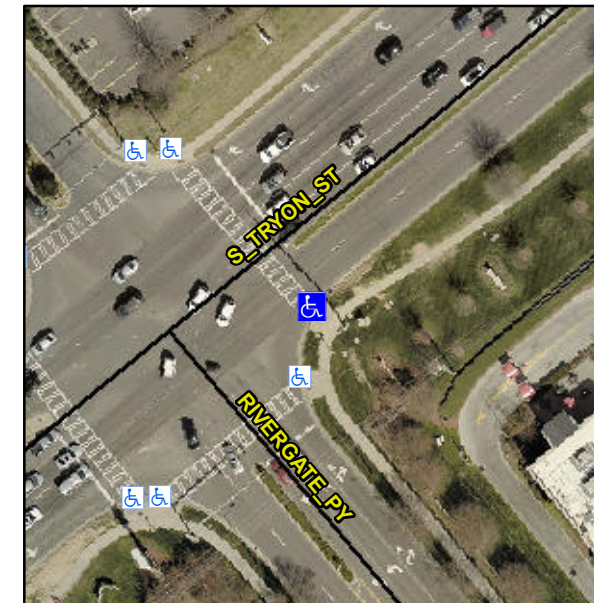
Not Found, R304.5.1, R304.5.3

Compliance	Description	Data	Compliance	Description	Data
N/A	Ramp Length (in)	96.0	Yes	Ramp Slope (%)	8.1
No	Ramp Width (in)	46.0	No	Ramp XSlope (%)	4.3
N/A	Flare Type LT	N/A	N/A	Flare Type RT	N/A
N/A	Flare Slope LT (%)	N/A	N/A	Flare Slope RT (%)	N/A
N/A	Flare Traversable LT?	N/A	N/A	Flare Traversable RT?	N/A
N/A	Landing Length (in)	N/A	N/A	DWS Provided?	N/A
N/A	Landing Width (in)	N/A	N/A	DWS Contrast?	N/A
N/A	Landing Slope (%)	N/A	N/A	DWS Length (in)	N/A
N/A	Landing X Slope (%)	N/A	N/A	DWS Full Width?	N/A
N/A	Landing Curb? (Y/N)	N/A	N/A	DWS Offset (in)	N/A
N/A	Shared Landing?	N/A			
N/A	Gutter Ponding?	N/A	N/A	Gutter Slope (%)	N/A
N/A	Gutter Lip Ht (in)	N/A	N/A	Gutter X Slope (%)	N/A
N/A	Painted X Walk1?	Yes	N/A	Painted X Walk2?	N/A
	X Walk 1 Direction	To N		X Walk 2 Direction	N/A
N/A	X Walk 1 Width (in)	106.0	N/A	X Walk 2 Width (in)	N/A
	X Walk 1 Slope (%)	1.1		X Walk 2 Slope (%)	N/A
	X Walk 1 X Slope (%)	3.3		X Walk 2 X Slope (%)	N/A

N/A	Ramp inside XWalk1?	Yes	N/A	Ramp inside XWalk2?	N/A
	Road Slope (%)	N/A	N/A	Clear Space?	N/A
	Road X Slope (%)	N/A	N/A	Clear Space to XWalk (in)	N/A
N/A	Any Obstructions?	N/A	N/A	Storm Grate/Utility Hazard?	N/A
	Obstruction Type			Storm Grate/Utility Type	
		N/A			N/A
		Yes		Surface Condition? (G/P)	Good

Remove & Replace Entire Ramp.

Total Cost: \$ 1850.00
