## **Access Compliance Report Public Rights-of-Way** (Curb Ramps)

Intersection ID: 15806 Main Street: EAST BV **Cross Street: MARYLAND AV** Location: SW ADA ID: AD5A7F3053EA Ramp Type: BlendTrans2 Initial Pass/Fail: Fail **Overall Compliance: No Severity Score:** 1.25

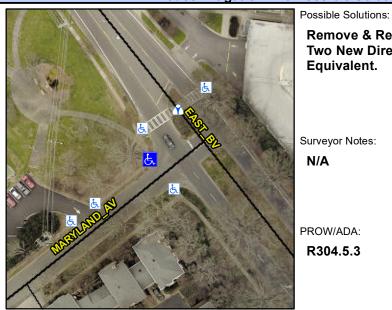
Comp	liance Description	Data	Comp	liance Description	Data
N/A	Ramp Length (in)	86.0	Yes	BlendTrans Slope (%)	3.3
Yes	Ramp Width (in)	73.0	No	BlendTrans XSlope (%)	4.0
N/A	Flare Type LT	N/A	N/A	Flare Type RT	N/A
N/A	Flare Slope LT (%)	N/A	N/A	Flare Slope RT (%)	N/A
N/A	Flare Traversable LT?	N/A	N/A	Flare Traversable RT?	N/A
N/A	Landing Length (in)	N/A	N/A	DWS Provided?	N/A
N/A	Landing Width (in)	N/A	N/A	DWS Contrast?	N/A
N/A	Landing Slope (%)	N/A	N/A	DWS Length (in)	N/A
N/A	Landing X Slope (%)	N/A	N/A	DWS Full Width?	N/A
N/A	Landing Curb? (Y/N)	N/A	N/A	DWS Offset (in)	N/A
N/A	Shared Landing?	N/A			
N/A	Gutter Ponding?	N/A	N/A	Gutter Slope (%)	N/A
N/A	Gutter Lip Ht (in)	0.5	N/A	Gutter X Slope (%)	N/A
N/A	Painted X Walk1?	No	N/A	Painted X Walk2?	N/A
	X Walk 1 Direction	To SE		X Walk 2 Direction	N/A
	X Walk 1 Width (in)	N/A		X Walk 2 Width (in)	N/A
	X Walk 1 Slope (%)	3.0		X Walk 2 Slope (%)	N/A
	X Walk 1 X Slope (%)	1.6		X Walk 2 X Slope (%)	N/A

N/A	Ramp inside XWalk1?	N/A	N/A	Ramp inside XWalk2?	N/A
	Road Slope (%)	1.6		Clear Space?	N/A
	Road X Slope (%)	3.0	N/A	Clear Space to XWalk (in)	N/A
N/A	Any Obstructions?	N/A	N/A	Storm Grate/Utility Hazard?	N/A
	Obstruction Type			Storm Grate/Utility Type	
		N/A			N/A
			Yes	Surface Condition? (G/P)	Good
	2 1 2 1 3 E		N/A	Curb Slope (%)	2.2

Street 1 Name Stop Condition-Street 1 Street 2 Name Stop Condition-Street 2 **Remove & Replace Curb Ramp With Two New Directional Ramps or** Equivalent.

R304.5.3

**MARYLAND AV** StopSign N/A N/A Total Cost: 3200.00
