Access Compliance Report

Public Rights-of-Way

(Curb Ramps)

Intersection ID: 10017663	Main Street: STATESVILLE_AV	Cross Street: N/A	Location: E
ADA ID: AD621BF80E8A	Ramp Type: BlendTrans1	Initial Pass/Fail: Fail	Overall Compliance: No
		Severity Score: 10

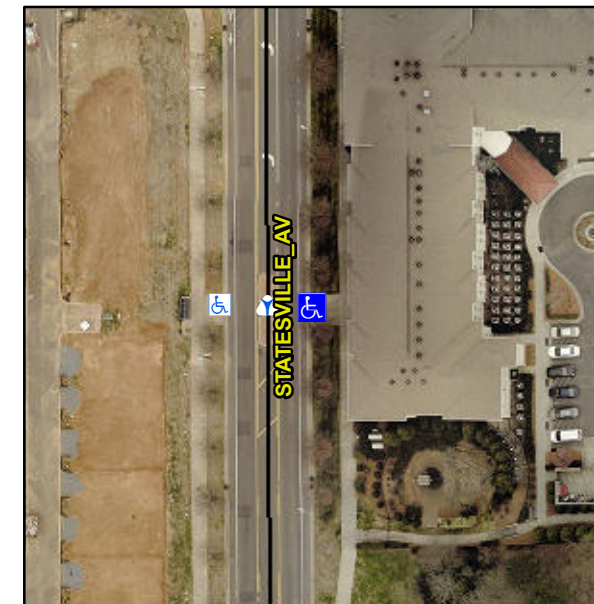
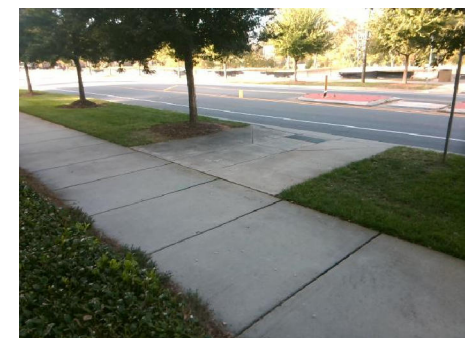
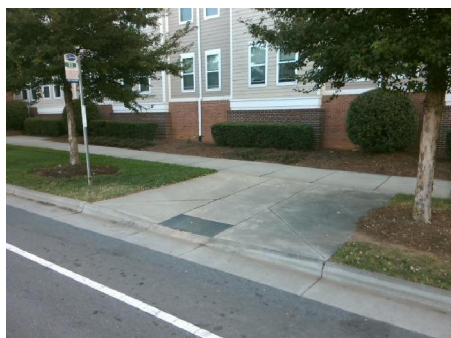
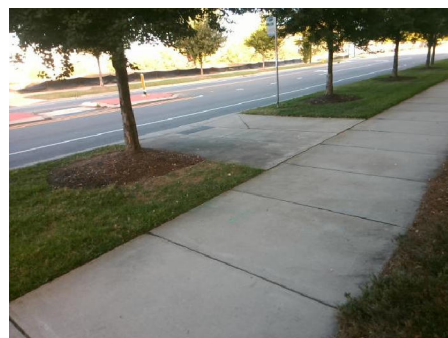
Not Found, R304.5.1, R304.5.3

Compliance	Description	Data	Compliance	Description	Data
N/A	Ramp Length (in)	172.0	Yes	BlendTrans Slope (%)	3.5
No	Ramp Width (in)	47.0	No	BlendTrans XSlope (%)	2.3
N/A	Flare Type LT	N/A	N/A	Flare Type RT	N/A
N/A	Flare Slope LT (%)	N/A	N/A	Flare Slope RT (%)	N/A
N/A	Flare Traversable LT?	N/A	N/A	Flare Traversable RT?	N/A
N/A	Landing Length (in)	N/A	N/A	DWS Provided?	N/A
N/A	Landing Width (in)	N/A	N/A	DWS Contrast?	N/A
N/A	Landing Slope (%)	N/A	N/A	DWS Length (in)	N/A
N/A	Landing X Slope (%)	N/A	N/A	DWS Full Width?	N/A
N/A	Landing Curb? (Y/N)	N/A	N/A	DWS Offset (in)	N/A
N/A	Shared Landing?	N/A			
N/A	Gutter Ponding?	N/A	N/A	Gutter Slope (%)	N/A
N/A	Gutter Lip Ht (in)	N/A	N/A	Gutter X Slope (%)	N/A
N/A	Painted X Walk1?	No	N/A	Painted X Walk2?	N/A
	X Walk 1 Direction	To W		X Walk 2 Direction	N/A
	X Walk 1 Width (in)	N/A		X Walk 2 Width (in)	N/A
	X Walk 1 Slope (%)	3.7		X Walk 2 Slope (%)	N/A
	X Walk 1 X Slope (%)	2.1		X Walk 2 X Slope (%)	N/A

N/A	Ramp inside XWalk1?	N/A	N/A	Ramp inside XWalk2?	N/A
	Road Slope (%)	2.1		Clear Space?	N/A
	Road X Slope (%)	3.7	N/A	Clear Space to XWalk (in)	N/A
N/A	Any Obstructions?	N/A	N/A	Storm Grate/Utility Hazard?	N/A
	Obstruction Type			Storm Grate/Utility Type	
		N/A			N/A
			Yes	Surface Condition? (G/P)	Good
			No	Curb Slope (%)	24.6

Remove & Replace Curb Ramp With Two New Directional Ramps or Equivalent.
