Access Compliance Report

Public Rights-of-Way (Curb Ramps)

Intersection ID: 16365	Main Street: QUEENS_RD	Cross Street: SHERWOOD_AV	Location: NW
ADA ID: AD69571A75E0	Ramp Type: Directional1	Initial Pass/Fail: Fail	Overall Compliance: No
		Severity Score: 25

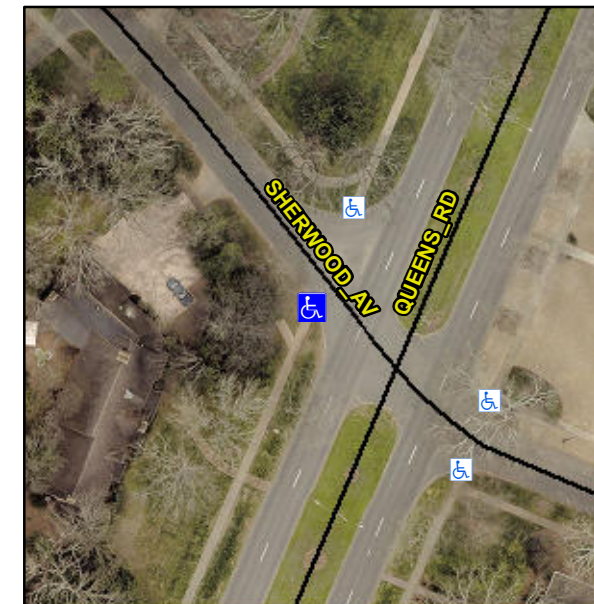
Compliance	Description	Data	Compliance	Description	Data
N/A	Ramp Length (in)	69.0	N/A	Grade Break?	N/A
Yes	Ramp Width (in)	62.0	N/A	Grade Break Slope (%)	0.0
Yes	Ramp Slope (%)	3.4	N/A	Grade Break XSlope (%)	0.0
No	Ramp XSlope (%)	10.9			
N/A	Flare Type LT	N/A	N/A	Flare Type RT	N/A
N/A	Flare Slope LT (%)	N/A	N/A	Flare Slope RT (%)	0.0
N/A	Flare Traversable LT?	N/A	N/A	Flare Traversable RT?	N/A
N/A	Landing Length (in)	0.0	N/A	DWS Provided?	N/A
N/A	Landing Width (in)	0.0	N/A	DWS Contrast?	N/A
N/A	Landing Slope (%)	0.0	N/A	DWS Length (in)	N/A
N/A	Landing X Slope (%)	0.0	N/A	DWS Full Width?	N/A
N/A	Landing Curb? (Y/N)	N/A	N/A	DWS Offset LT (in)	N/A
N/A	Shared Landing?	N/A	N/A	DWS Offset RT (in)	N/A
N/A	Gutter Ponding?	0.0	N/A	Gutter Slope (%)	N/A
N/A	Gutter Lip Ht (in)	0.0	N/A	Gutter X Slope (%)	N/A
N/A	Painted X Walk1?	No		Road Slope (%)	3.5
	X Walk 1 Direction	To N		Road X Slope (%)	2.2
	X Walk 1 Width (in)	N/A		Clear Space?	N/A

X Walk 1 Slope (%)	3.5	N/A	Clear Space to XWalk (in)	N/A
	X Walk 1 X Slope (%)	2.2	N/A	Storm Grate/Utility Hazard?	N/A
N/A	Ramp inside XWalk1?	N/A		Storm Grate/Utility Type	
N/A	Any Obstructions?	N/A			N/A
	Obstruction Type		Yes	Surface Condition? (G/P)	Good
			N/A	Curb Slope (%)	5.8

Possible Solutions:

Remove & Replace Entire Ramp.

R304.5.3
