Access Compliance Report

Public Rights-of-Way

(Curb Ramps)

Intersection ID: 43759	Main Street: DERVISH_LN	Cross Street: DUXFORD_LN	Location: SW
ADA ID: AD7EA813B6C2	Ramp Type: PerpDiag	Initial Pass/Fail: Fail	Overall Compliance: No
Severity Score: 17.5			
Codes/Mitigation Info/Possible Solution		Field Measurements/Component Compliance

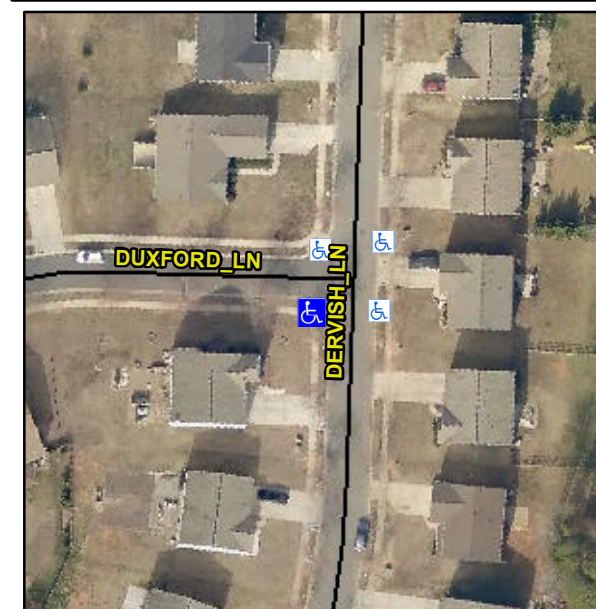
Not Found, R304.5.1

Compliance	Description	Data	Compliance	Description	Data
N/A	Ramp Length (in)	48.0	Yes	Ramp Slope (%)	5.2
No	Ramp Width (in)	35.0	Yes	Ramp XSlope (%)	0.8
N/A	Flare Type LT	N/A	N/A	Flare Type RT	N/A
N/A	Flare Slope LT (%)	N/A	N/A	Flare Slope RT (%)	N/A
N/A	Flare Traversable LT?	N/A	N/A	Flare Traversable RT?	N/A
N/A	Landing Length (in)	N/A	N/A	DWS Provided?	N/A
N/A	Landing Width (in)	N/A	N/A	DWS Contrast?	N/A
N/A	Landing Slope (%)	N/A	N/A	DWS Length (in)	N/A
N/A	Landing X Slope (%)	N/A	N/A	DWS Full Width?	N/A
N/A	Landing Curb? (Y/N)	N/A	N/A	DWS Offset (in)	N/A
N/A	Shared Landing?	N/A			
N/A	Gutter Ponding?	N/A	N/A	Gutter Slope (%)	N/A
N/A	Gutter Lip Ht (in)	N/A	N/A	Gutter X Slope (%)	N/A
N/A	Painted X Walk1?	No	N/A	Painted X Walk2?	No
	X Walk 1 Direction	To E		X Walk 2 Direction	To N
N/A	X Walk 1 Width (in)	N/A	N/A	X Walk 2 Width (in)	N/A
	X Walk 1 Slope (%)	2.4		X Walk 2 Slope (%)	2.6
	X Walk 1 X Slope (%)	3.3		X Walk 2 X Slope (%)	2.2

N/A	Ramp inside XWalk1?	N/A	N/A	Ramp inside XWalk2?	N/A
	Road Slope (%)	0.4	N/A	Clear Space?	N/A
	Road X Slope (%)	4.6	N/A	Clear Space to XWalk (in)	N/A
N/A	Any Obstructions?	N/A	N/A	Storm Grate/Utility Hazard?	N/A
	Obstruction Type			Storm Grate/Utility Type	
		N/A			N/A
			Yes	Surface Condition? (G/P)	Good

Possible Solutions:

Remove & Replace Curb Ramp With Two New Directional Ramps or Equivalent.
