# Access Compliance Report

## Public Rights-of-Way

### (Curb Ramps)

Intersection ID: 43522	Main Street: MISTRAL_WY	Cross Street: PALM_BREEZE_LN	Location: S
ADA ID: AD852C582456	Ramp Type: BlendTrans1	Initial Pass/Fail: Fail	Overall Compliance: No
Severity Score: 21.25			
Codes/Mitigation Info/Possible Solution		Field Measurements/Component Compliance

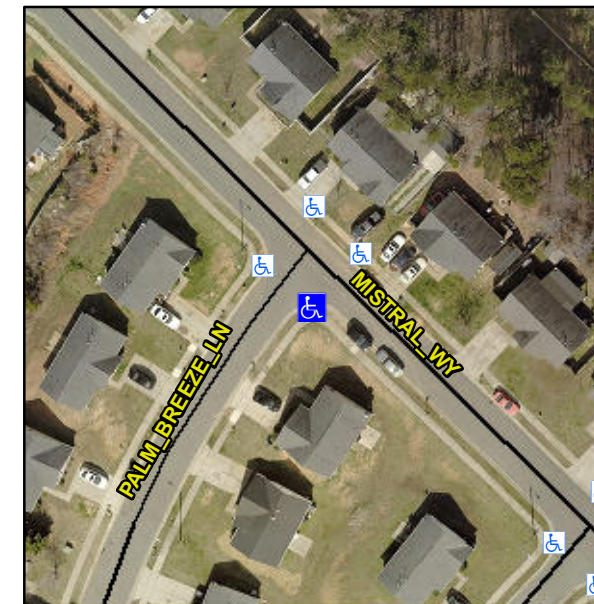
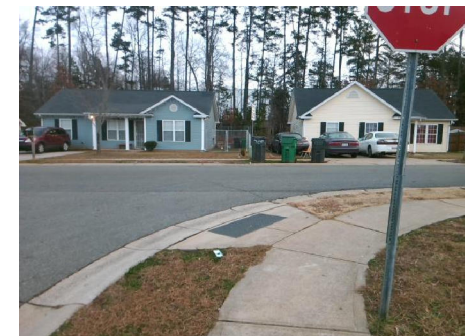
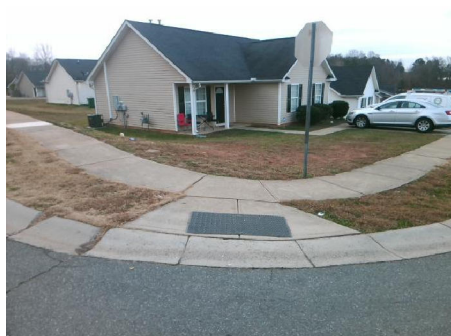
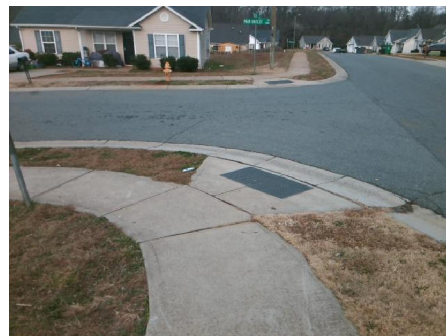
**Not Found, R304.5.1, R304.5.3**

Compliance	Description	Data	Compliance	Description	Data
N/A	Ramp Length (in)	48.0	Yes	BlendTrans Slope (%)	1.7
No	Ramp Width (in)	46.5	No	BlendTrans XSlope (%)	6.4
N/A	Flare Type LT	N/A	N/A	Flare Type RT	N/A
N/A	Flare Slope LT (%)	N/A	N/A	Flare Slope RT (%)	N/A
N/A	Flare Traversable LT?	N/A	N/A	Flare Traversable RT?	N/A
N/A	Landing Length (in)	N/A	N/A	DWS Provided?	N/A
N/A	Landing Width (in)	N/A	N/A	DWS Contrast?	N/A
N/A	Landing Slope (%)	N/A	N/A	DWS Length (in)	N/A
N/A	Landing X Slope (%)	N/A	N/A	DWS Full Width?	N/A
N/A	Landing Curb? (Y/N)	N/A	N/A	DWS Offset (in)	N/A
N/A	Shared Landing?	N/A			
N/A	Gutter Ponding?	N/A	N/A	Gutter Slope (%)	N/A
N/A	Gutter Lip Ht (in)	N/A	N/A	Gutter X Slope (%)	N/A
N/A	Painted X Walk1?	No	N/A	Painted X Walk2?	No
	X Walk 1 Direction	To NE		X Walk 2 Direction	To NW
	X Walk 1 Width (in)	N/A		X Walk 2 Width (in)	N/A
	X Walk 1 Slope (%)	7.8		X Walk 2 Slope (%)	1.3
	X Walk 1 X Slope (%)	3.6		X Walk 2 X Slope (%)	6.5

N/A	Ramp inside XWalk1?	N/A	N/A	Ramp inside XWalk2?	N/A
	Road Slope (%)	6.6		Clear Space?	N/A
	Road X Slope (%)	4.2	N/A	Clear Space to XWalk (in)	N/A
N/A	Any Obstructions?	N/A	N/A	Storm Grate/Utility Hazard?	N/A
	Obstruction Type			Storm Grate/Utility Type	
		N/A			N/A
			Yes	Surface Condition? (G/P)	Good
			No	Curb Slope (%)	7.3

**Remove & Replace Curb Ramp With Two New Directional Ramps or Equivalent.**
