# Access Compliance Report

## Public Rights-of-Way

### (Curb Ramps)

Intersection ID: 29696	Main Street: CAMERON_CREEK_DR	Cross Street: KENWOOD_TERRACE_DR	Location: S
ADA ID: AD8910A47943	Ramp Type: PerpDiag	Initial Pass/Fail: Fail	Overall Compliance: No
Severity Score: 17.5			
Codes/Mitigation Info/Possible Solution		Field Measurements/Component Compliance

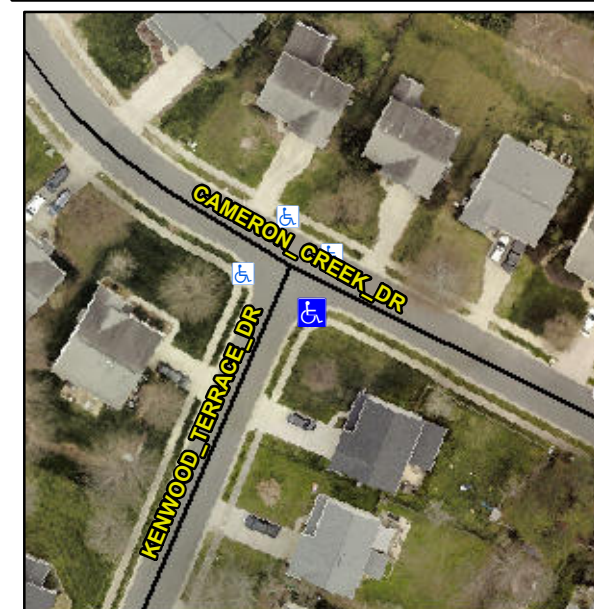
Compliance	Description	Data	Compliance	Description	Data
N/A	Ramp Length (in)	46.0	Yes	Ramp Slope (%)	7.7
No	Ramp Width (in)	32.0	Yes	Ramp XSlope (%)	1.7
N/A	Flare Type LT	N/A	N/A	Flare Type RT	N/A
N/A	Flare Slope LT (%)	N/A	N/A	Flare Slope RT (%)	N/A
N/A	Flare Traversable LT?	N/A	N/A	Flare Traversable RT?	N/A
N/A	Landing Length (in)	N/A	N/A	DWS Provided?	N/A
N/A	Landing Width (in)	N/A	N/A	DWS Contrast?	N/A
N/A	Landing Slope (%)	N/A	N/A	DWS Length (in)	N/A
N/A	Landing X Slope (%)	N/A	N/A	DWS Full Width?	N/A
N/A	Landing Curb? (Y/N)	N/A	N/A	DWS Offset (in)	N/A
N/A	Shared Landing?	N/A			
N/A	Gutter Ponding?	N/A	N/A	Gutter Slope (%)	N/A
N/A	Gutter Lip Ht (in)	N/A	N/A	Gutter X Slope (%)	N/A
N/A	Painted X Walk1?	No	N/A	Painted X Walk2?	No
	X Walk 1 Direction	To NE		X Walk 2 Direction	To NW
N/A	X Walk 1 Width (in)	N/A	N/A	X Walk 2 Width (in)	N/A
	X Walk 1 Slope (%)	3.7		X Walk 2 Slope (%)	2.6
	X Walk 1 X Slope (%)	2.6		X Walk 2 X Slope (%)	0.9

N/A	Ramp inside XWalk1?	N/A	N/A	Ramp inside XWalk2?	N/A
	Road Slope (%)	0.1	N/A	Clear Space?	N/A
	Road X Slope (%)	3.4	N/A	Clear Space to XWalk (in)	N/A
N/A	Any Obstructions?	N/A	N/A	Storm Grate/Utility Hazard?	N/A
	Obstruction Type			Storm Grate/Utility Type	
		N/A			N/A
			Yes	Surface Condition? (G/P)	Good

Possible Solutions:

**Remove & Replace Curb Ramp With Two New Directional Ramps or Equivalent.**

**R304.5.1**
