Access Compliance Report

Public Rights-of-Way

(Curb Ramps)

Intersection ID: 5087	Main Street: EMERALD_COVE_DR	Cross Street: GLENWATER_DR	Location:	N
ADA ID: AD8A1A26EDFF	Ramp Type: BlendTrans1	Initial Pass/Fail: Pass	Overall Compliance: No	Severity Score: 25

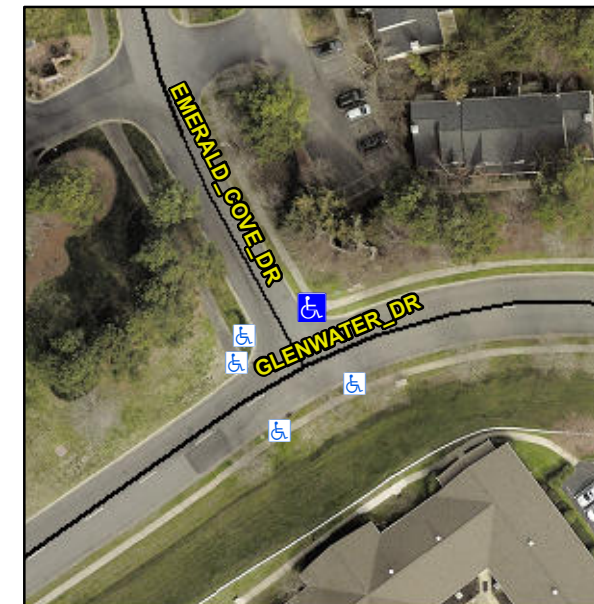
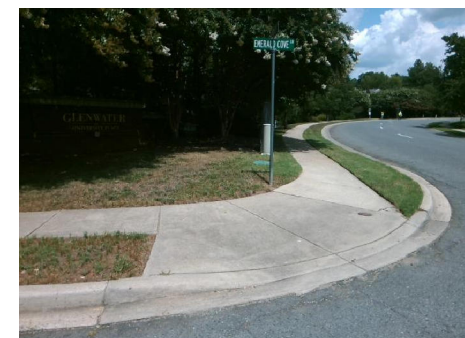
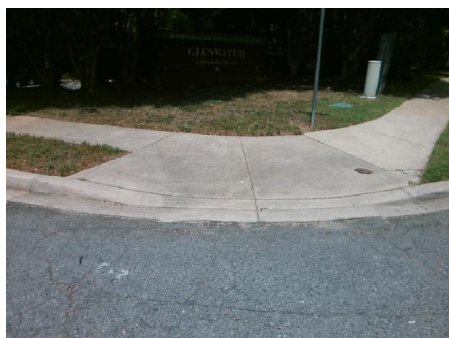
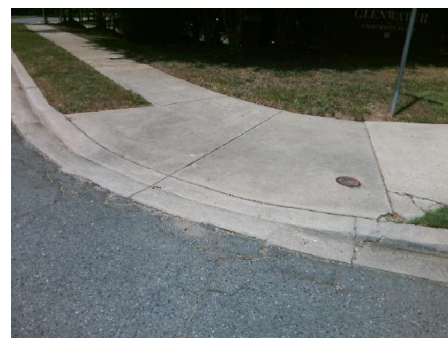
Not Found, R304.2.2-Perp, R304.3.2-Para, R304.5.3, R305, R302.7.2, R302.3, R402.2

Compliance	Description	Data	Compliance	Description	Data
N/A	Ramp Length (in)	45.5	Yes	BlendTrans Slope (%)	3.1
Yes	Ramp Width (in)	87.0	Yes	BlendTrans XSlope (%)	1.2
N/A	Flare Type LT	Sloped	N/A	Flare Type RT	Sloped
N/A	Flare Slope LT (%)	8.6	Yes	Flare Slope RT (%)	7.5
N/A	Flare Traversable LT?	No	N/A	Flare Traversable RT?	Yes
Yes	Landing Length (in)	51.0	No	DWS Provided?	No
Yes	Landing Width (in)	87.0	N/A	DWS Contrast?	No
No	Landing Slope (%)	2.5	N/A	DWS Length (in)	N/A
No	Landing X Slope (%)	11.0	N/A	DWS Full Width?	No
N/A	Landing Curb? (Y/N)	No	N/A	DWS Offset (in)	N/A
N/A	Shared Landing?	No			
Yes	Gutter Ponding?	No	Yes	Gutter Slope (%)	0.6
No	Gutter Lip Ht (in)	1.0	Yes	Gutter X Slope (%)	1.8
N/A	Painted X Walk1?	No	N/A	Painted X Walk2?	No
	X Walk 1 Direction	To SW		X Walk 2 Direction	To SE
	X Walk 1 Width (in)	N/A		X Walk 2 Width (in)	N/A
	X Walk 1 Slope (%)	5.0		X Walk 2 Slope (%)	6.7
	X Walk 1 X Slope (%)	2.1		X Walk 2 X Slope (%)	0.2

N/A	Ramp inside XWalk1?	N/A	N/A	Ramp inside XWalk2?	N/A
	Road Slope (%)	1.3		Clear Space?	Yes
	Road X Slope (%)	4.3	N/A	Clear Space to XWalk (in)	N/A
Yes	Any Obstructions?	No	No	Storm Grate/Utility Hazard?	Yes
	Obstruction Type			Storm Grate/Utility Type	
		N/A			N/A
			Yes	Surface Condition? (G/P)	Good
			No	Curb Slope (%)	8.5

Remove & Replace Curb Ramp With Two New Directional Ramps or Equivalent. Utility Present.
