Access Compliance Report Public Rights-of-Way (Curb Ramps)

Intersection ID: 51668Main Street:BROWNE_RDCross Street:SWEETBRIAR_RIDGE_DRLocation:WADA ID: AD8A4DE104C6Ramp Type:ParaInitial Pass/Fail:FailOverall Compliance:NoSeverity Score:1.25

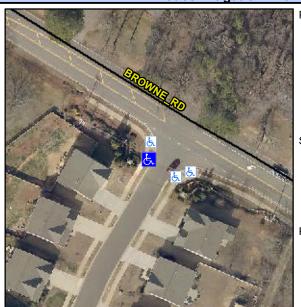
LT RP < 5%

R304.5.3

| Compliance Description Data Compliance Description Data | | | | | |
|---|---|---|---|---|---|
| Yes | Ramp XSlope LT (%) | 1.8 | No | Ramp XSlope RT (%) | 2.4 |

Remove & Replace Entire Ramp.

Total Cost: \$ 1600.00
