# Access Compliance Report

## Public Rights-of-Way

### (Curb Ramps)

| Intersection ID: 9858 | Main Street: MERCURY_ST | Cross Street: N_DAVIDSON_ST | Location: NE |

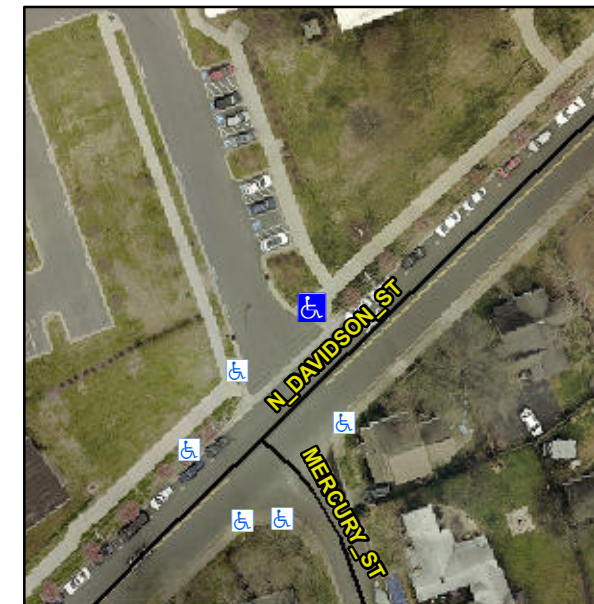
**R304.5.3, R305.2**

| Compliance | Description | Data | Compliance | Description | Data |
|---|---|---|---|---|---|
| N/A | Ramp Length (in) | 132.0 | Yes | Ramp Slope (%) | 6.6 |
| No | Landing X Slope (%) | 3.8 | Yes | DWS Full Width? | Yes |
| N/A | Landing Curb? (Y/N) | No | No | DWS Offset (in) | 4.5 |

**Remove & Replace Curb Ramp With Two New Directional Ramps or Equivalent.**

Total Cost: \$ 3200.00
