Access Compliance Report

Public Rights-of-Way

(Curb Ramps)

Intersection ID: 8722	Main Street: LANDER_ST	Cross Street: ROZZELLES_FERRY_RD	Location: S
ADA ID: AD9AFA366A5E	Ramp Type: BlendTrans1	Initial Pass/Fail: Fail	Overall Compliance: No
Codes/Mitigation Info/Possible Solution		Field Measurements/Component Compliance	
Severity Score: 8.75

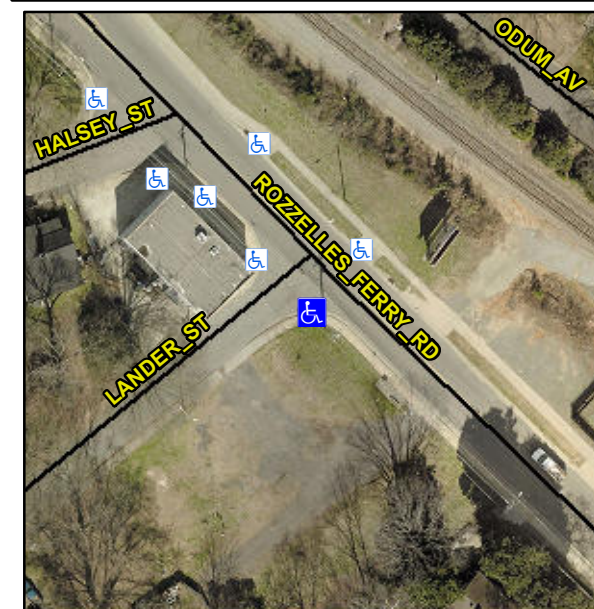
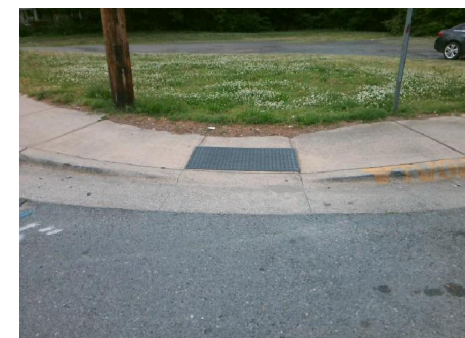
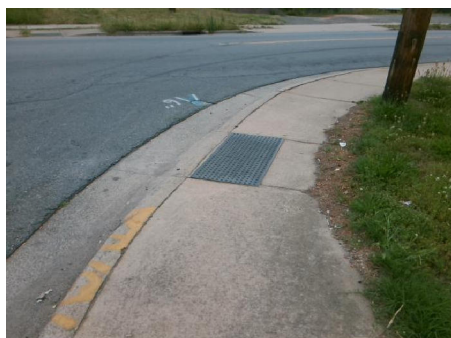
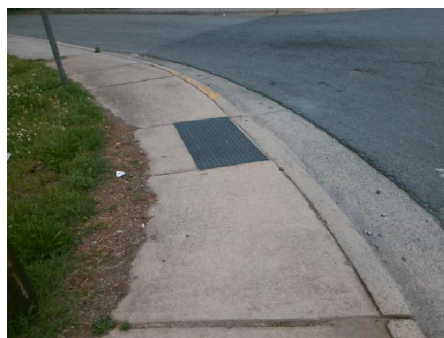
Not Found, R304.5.1

Compliance	Description	Data	Compliance	Description	Data
N/A	Ramp Length (in)	50.0	Yes	BlendTrans Slope (%)	4.6
No	Ramp Width (in)	44.0	Yes	BlendTrans XSlope (%)	1.8
N/A	Flare Type LT	N/A	N/A	Flare Type RT	N/A
N/A	Flare Slope LT (%)	N/A	N/A	Flare Slope RT (%)	N/A
N/A	Flare Traversable LT?	N/A	N/A	Flare Traversable RT?	N/A
N/A	Landing Length (in)	N/A	N/A	DWS Provided?	N/A
N/A	Landing Width (in)	N/A	N/A	DWS Contrast?	N/A
N/A	Landing Slope (%)	N/A	N/A	DWS Length (in)	N/A
N/A	Landing X Slope (%)	N/A	N/A	DWS Full Width?	N/A
N/A	Landing Curb? (Y/N)	N/A	N/A	DWS Offset (in)	N/A
N/A	Shared Landing?	N/A			
N/A	Gutter Ponding?	N/A	N/A	Gutter Slope (%)	N/A
N/A	Gutter Lip Ht (in)	1.0	N/A	Gutter X Slope (%)	N/A
N/A	Painted X Walk1?	No	N/A	Painted X Walk2?	No
	X Walk 1 Direction	To NE		X Walk 2 Direction	To NW
	X Walk 1 Width (in)	N/A		X Walk 2 Width (in)	N/A
	X Walk 1 Slope (%)	6.5		X Walk 2 Slope (%)	2.9
	X Walk 1 X Slope (%)	1.9		X Walk 2 X Slope (%)	2.8

N/A	Ramp inside XWalk1?	N/A	N/A	Ramp inside XWalk2?	N/A
	Road Slope (%)	2.1		Clear Space?	N/A
	Road X Slope (%)	4.4	N/A	Clear Space to XWalk (in)	N/A
N/A	Any Obstructions?	N/A	N/A	Storm Grate/Utility Hazard?	N/A
	Obstruction Type			Storm Grate/Utility Type	
		N/A			N/A
			Yes	Surface Condition? (G/P)	Good
			No	Curb Slope (%)	15.5

Remove & Replace Curb Ramp With Two New Directional Ramps or Equivalent.

Total Cost: \$ 3200.00
