Access Compliance Report

Public Rights-of-Way

(Curb Ramps)

Intersection ID: 44850	Main Street: STEELE_CREEK_RD	Cross Street: SHOPTON_RD_WEST	Location: NW
ADA ID: AD9D4BE0538A	Ramp Type: Para	Initial Pass/Fail: Fail	Overall Compliance: No
Severity Score: 26.25			
Codes/Mitigation Info/Possible Solution		Field Measurements/Component Compliance

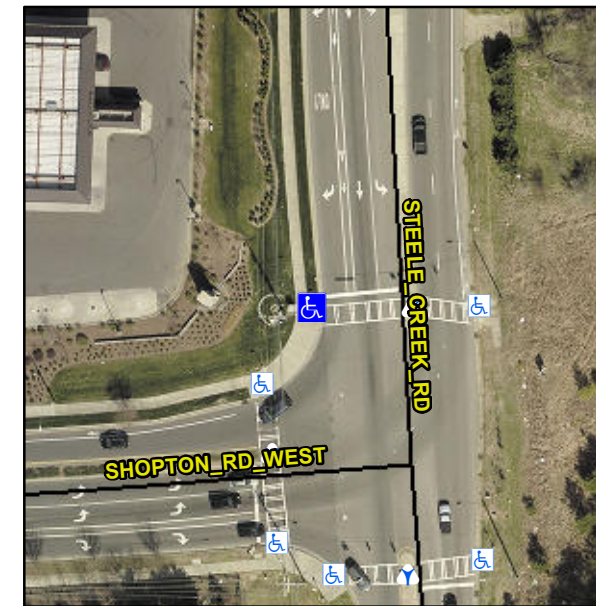
LT RP < 5%

R304.5.3, R304.3.2

Compliance	Description	Data	Compliance	Description	Data
N/A	Ramp Length LT (in)	54.0	N/A	Ramp Length RT (in)	59.0
Yes	Ramp Width LT (in)	70.0	Yes	Ramp Width RT (in)	70.0
Yes	Ramp Slope LT (%)	1.4	No	Ramp Slope RT (%)	12.0
No	Ramp XSlope LT (%)	2.7	Yes	Ramp XSlope RT (%)	0.6
N/A	Landing Length (in)	N/A	N/A	DWS Provided?	N/A
N/A	Landing Width (in)	N/A	N/A	DWS Contrast?	N/A
N/A	Landing Slope (%)	N/A	N/A	DWS Length (in)	N/A
N/A	Landing X Slope (%)	N/A	N/A	DWS Full Width?	N/A
N/A	Landing Curb? (Y/N)	N/A	N/A	DWS Offset (in)	N/A
N/A	Shared Landing?	N/A			
N/A	Gutter Ponding?	N/A	N/A	Gutter Slope (%)	N/A
N/A	Gutter Lip Ht (in)	N/A	N/A	Gutter X Slope (%)	N/A
N/A	Painted X Walk1?	Yes	N/A	Painted X Walk2?	N/A
	X Walk 1 Direction	To E		X Walk 2 Direction	N/A
N/A	X Walk 1 Width (in)	113.0	N/A	X Walk 2 Width (in)	N/A
	X Walk 1 Slope (%)	1.8		X Walk 2 Slope (%)	N/A
	X Walk 1 X Slope (%)	3.0		X Walk 2 X Slope (%)	N/A
N/A	Ramp inside XWalk1?	Yes	N/A	Ramp inside XWalk2?	N/A

Road Slope (%)	N/A	N/A	Clear Space?	N/A
	Road X Slope (%)	N/A	N/A	Clear Space to XWalk (in)	N/A
N/A	Any Obstructions?	N/A	N/A	Storm Grate/Utility Hazard?	N/A
	Obstruction Type			Storm Grate/Utility Type	
		N/A			N/A
			Yes	Surface Condition? (G/P)	Good
			N/A	Curb Slope (%)	12.6

Remove & Replace Entire Ramp.

Total Cost: \$ 1600.00
