# Access Compliance Report

## Public Rights-of-Way

### (Curb Ramps)

Intersection ID: 14705	Main Street: ALBEMARLE_RD	Cross Street: LYNTON_BV	Location: SE
ADA ID: ADA8F3355DFD	Ramp Type: Perp	Initial Pass/Fail: Fail	Overall Compliance: No
Severity Score: 10			
Codes/Mitigation Info/Possible Solution		Field Measurements/Component Compliance

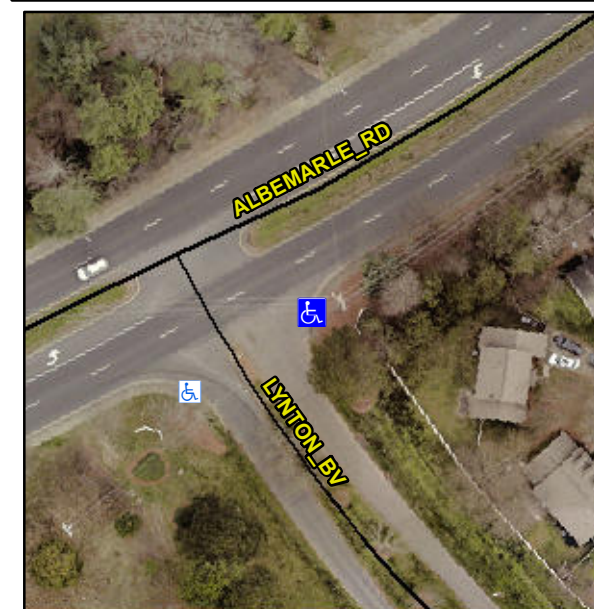
**Not Found, R304.5.1, R304.5.3**

Compliance	Description	Data	Compliance	Description	Data
N/A	Ramp Length (in)	61.0	Yes	Ramp Slope (%)	8.3
No	Ramp Width (in)	42.0	No	Ramp XSlope (%)	2.1
N/A	Flare Type LT	N/A	N/A	Flare Type RT	N/A
N/A	Flare Slope LT (%)	N/A	N/A	Flare Slope RT (%)	N/A
N/A	Flare Traversable LT?	N/A	N/A	Flare Traversable RT?	N/A
N/A	Landing Length (in)	N/A	N/A	DWS Provided?	N/A
N/A	Landing Width (in)	N/A	N/A	DWS Contrast?	N/A
N/A	Landing Slope (%)	N/A	N/A	DWS Length (in)	N/A
N/A	Landing X Slope (%)	N/A	N/A	DWS Full Width?	N/A
N/A	Landing Curb? (Y/N)	N/A	N/A	DWS Offset (in)	N/A
N/A	Shared Landing?	N/A			
N/A	Gutter Ponding?	N/A	N/A	Gutter Slope (%)	N/A
N/A	Gutter Lip Ht (in)	N/A	N/A	Gutter X Slope (%)	N/A
N/A	Painted X Walk1?	No	N/A	Painted X Walk2?	N/A
	X Walk 1 Direction	To W		X Walk 2 Direction	N/A
N/A	X Walk 1 Width (in)	N/A	N/A	X Walk 2 Width (in)	N/A
	X Walk 1 Slope (%)	3.4		X Walk 2 Slope (%)	N/A
	X Walk 1 X Slope (%)	0.7		X Walk 2 X Slope (%)	N/A

**Remove & Replace Entire Ramp.**

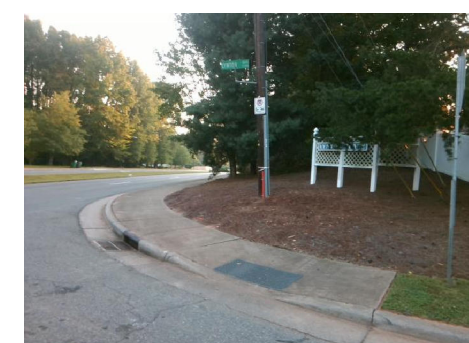
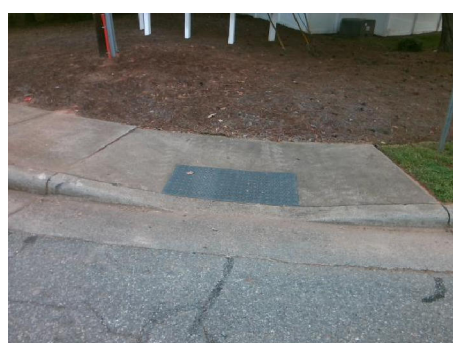
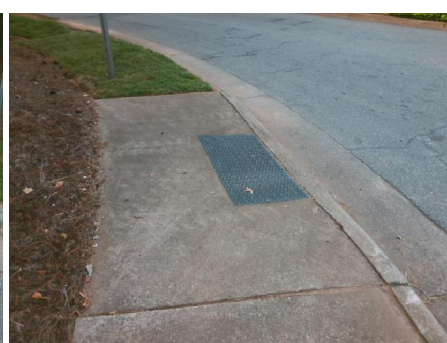
N/A	Ramp inside XWalk1?	N/A	N/A	Ramp inside XWalk2?	N/A
	Road Slope (%)	N/A	N/A	Clear Space?	N/A
	Road X Slope (%)	N/A	N/A	Clear Space to XWalk (in)	N/A
N/A	Any Obstructions?	N/A	N/A	Storm Grate/Utility Hazard?	N/A
	Obstruction Type			Storm Grate/Utility Type	
		N/A			N/A
			Yes	Surface Condition? (G/P)	Good
