Access Compliance Report Public Rights-of-Way (Curb Ramps)

Intersection ID: 9491Main Street: JUDSON_AVCross Street: N/ALocation:SWADA ID: ADAF34C7E1F0Ramp Type: PerpInitial Pass/Fail: FailOverall Compliance: NoSeverity Score: 13.75

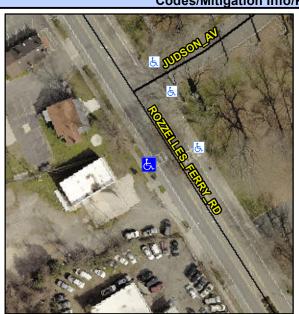
a55/F	ali. Fali Overali	Compilan	ice. N	d Severity Score.	13.73				
Field Measurements/Component Compliance									
Comp	liance Description	Data	Comp	liance Description	Data				
N/A	Ramp Length (in)	60.0	No	Ramp Slope (%)	9.3				
Yes	Ramp Width (in)	54.0	Yes	Ramp XSlope (%)	2.2				
N/A	Flare Type LT	N/A	N/A	Flare Type RT	N/A				
N/A	Flare Slope LT (%)	N/A	N/A	Flare Slope RT (%)	N/A				
N/A	Flare Traversable LT?	N/A	N/A	Flare Traversable RT?	N/A				
N/A	Landing Length (in)	N/A	N/A	DWS Provided?	N/A				
N/A	Landing Width (in)	N/A	N/A	DWS Contrast?	N/A				
N/A	Landing Slope (%)	N/A	N/A	DWS Length (in)	N/A				
N/A	Landing X Slope (%)	N/A	N/A	DWS Full Width?	N/A				
N/A	Landing Curb? (Y/N)	N/A	N/A	DWS Offset (in)	N/A				
N/A	Shared Landing?	N/A							
N/A	Gutter Ponding?	N/A	N/A	Gutter Slope (%)	N/A				
N/A	Gutter Lip Ht (in)	N/A	N/A	Gutter X Slope (%)	N/A				
N/A	Painted X Walk1?	Yes	N/A	Painted X Walk2?	N/A

X Walk 1 Direction	To NE		X Walk 2 Direction	N/A				
N/A	X Walk 1 Width (in)	108.0	N/A	X Walk 2 Width (in)	N/A				
	X Walk 1 Slope (%)	4.2		X Walk 2 Slope (%)	N/A				
	X Walk 1 X Slope (%)	2.4		X Walk 2 X Slope (%)	N/A				
N/A	Ramp inside XWalk1?	Yes	N/A	Ramp inside XWalk2?	N/A				
	Road Slope (%)	N/A	N/A	Clear Space?	N/A				
	Road X Slope (%)	N/A	N/A	Clear Space to XWalk (in)	N/A				
N/A	Any Obstructions?	N/A	N/A	Storm Grate/Utility Hazard?	N/A				
	Obstruction Type		l	Storm Grate/Utility Type					
		N/A			N/A				
			Yes	Surface Condition? (G/P)	Good

Possible Solutions:	Coi
Remove & Replace Entire Ramp.	N/A
Romovo a Ropidoo Emilio Ramp.	Yes
	N/A
	N/A
	N/A
	N/A
Surveyor Notes:	N/A
N/A	N/A
N/A	N/A
	N/A
	N/A
PROW/ADA:	N/A
Not Found, R304.2.2	N/A
Not 1 Juliu, N304.2.2	N/A
	1477
	N/A
	N/A

1850.00
