Intersection ID: 30333	Main Street: NORTH PARK_MALL_DR	Cross Street: EASTWAY_DR	Location:	NE
ADA ID: ADB1134A27BD	Ramp Type: Perp	Initial Pass/Fail: Pass	Overall Compliance: No	Severity Score: 27.75

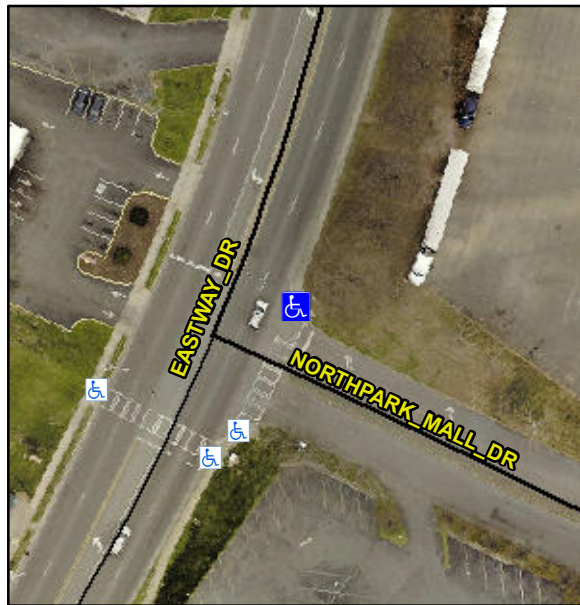
**Not Found, R304.5.3, R304.2.1,  
R304.2.2-Perp, R304.3.2-Para, R305,  
R302.7.2**

Compliance	Description	Data	Compliance	Description	Data
N/A	Ramp Length (in)	70.5	Yes	Ramp Slope (%)	6.1
Yes	Ramp Width (in)	52.5	No	Ramp XSlope (%)	2.9
N/A	Flare Type LT	Sloped	N/A	Flare Type RT	N/A
N/A	Flare Slope LT (%)	3.5	Yes	Flare Slope RT (%)	2.3
N/A	Flare Traversable LT?	Yes	N/A	Flare Traversable RT?	Yes
No	Landing Length (in)	N/A	No	DWS Provided?	No
No	Landing Width (in)	N/A	N/A	DWS Contrast?	No
No	Landing Slope (%)	N/A	N/A	DWS Length (in)	N/A
No	Landing X Slope (%)	N/A	N/A	DWS Full Width?	No
N/A	Landing Curb? (Y/N)	No	N/A	DWS Offset (in)	N/A
N/A	Shared Landing?	No			
Yes	Gutter Ponding?	No	Yes	Gutter Slope (%)	0.1
No	Gutter Lip Ht (in)	0.5	Yes	Gutter X Slope (%)	1.6
N/A	Painted X Walk1?	Yes	N/A	Painted X Walk2?	N/A
	X Walk 1 Direction	To SW		X Walk 2 Direction	N/A
N/A	X Walk 1 Width (in)	112.5	N/A	X Walk 2 Width (in)	N/A
	X Walk 1 Slope (%)	1.0		X Walk 2 Slope (%)	N/A
	X Walk 1 X Slope (%)	0.3		X Walk 2 X Slope (%)	N/A

Yes	Ramp inside XWalk1?	Yes	N/A	Ramp inside XWalk2?	N/A
	Road Slope (%)	N/A	N/A	Clear Space?	Yes
	Road X Slope (%)	N/A	N/A	Clear Space to XWalk (in)	N/A
Yes	Any Obstructions?	No	Yes	Storm Grate/Utility Hazard?	No
	Obstruction Type			Storm Grate/Utility Type	
		N/A			N/A
			Yes	Surface Condition? (G/P)	Good

### Remove & Replace Entire Ramp.
