Access Compliance Report Public Rights-of-Way (Curb Ramps)

Intersection ID: N/A Main Street: MILLENNIUM_AV Cross Street: CITY_PARK_DR Location: SE

ADA ID: ADB20DA5FAAF Ramp Type: Directional1 Initial Pass/Fail: Fail Overall Compliance: No Severity Score: 12.5

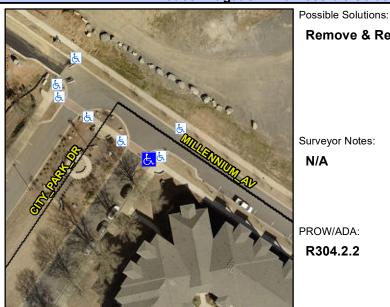
| Field Measurements/Component Compliance | | | | | |
|---|---|---|---|---|---|
| No | Ramp Slope (%) | 9.1 | N/A | Grade Break XSlope (%) | 0.0 |

Remove & Replace Entire Ramp.

PROW/ADA:
R304.2.2
