Access Compliance Report

Public Rights-of-Way

(Curb Ramps)

Intersection ID: 45493	Main Street: BUGGY_HORSE_RD	Cross Street: TREE_CANOPY_RD	Location: W
ADA ID: ADB23861255D	Ramp Type: Perp	Initial Pass/Fail: Fail	Overall Compliance: No
Severity Score: 12.5			
Codes/Mitigation Info/Possible Solution		Field Measurements/Component Compliance

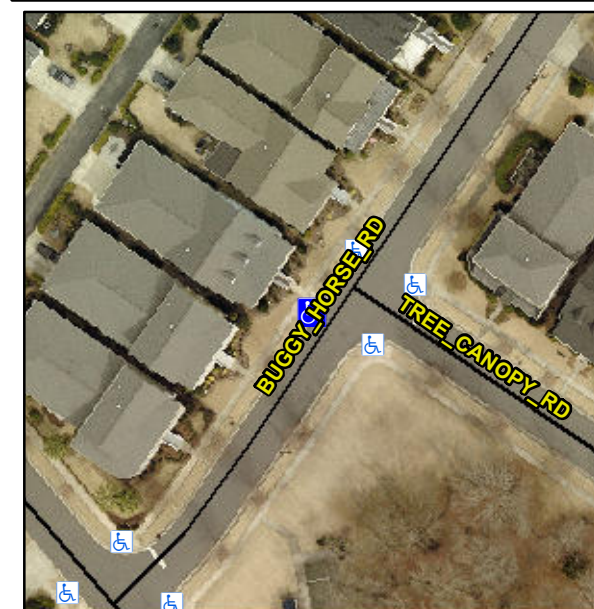
Not Found, R304.2.2

Compliance	Description	Data	Compliance	Description	Data
N/A	Ramp Length (in)	72.0	No	Ramp Slope (%)	10.6
Yes	Ramp Width (in)	48.0	Yes	Ramp XSlope (%)	0.1
N/A	Flare Type LT	N/A	N/A	Flare Type RT	N/A
N/A	Flare Slope LT (%)	N/A	N/A	Flare Slope RT (%)	N/A
N/A	Flare Traversable LT?	N/A	N/A	Flare Traversable RT?	N/A
N/A	Landing Length (in)	N/A	N/A	DWS Provided?	N/A
N/A	Landing Width (in)	N/A	N/A	DWS Contrast?	N/A
N/A	Landing Slope (%)	N/A	N/A	DWS Length (in)	N/A
N/A	Landing X Slope (%)	N/A	N/A	DWS Full Width?	N/A
N/A	Landing Curb? (Y/N)	N/A	N/A	DWS Offset (in)	N/A
N/A	Shared Landing?	N/A			
N/A	Gutter Ponding?	N/A	N/A	Gutter Slope (%)	N/A
N/A	Gutter Lip Ht (in)	N/A	N/A	Gutter X Slope (%)	N/A
N/A	Painted X Walk1?	No	N/A	Painted X Walk2?	N/A
	X Walk 1 Direction	To SE		X Walk 2 Direction	N/A
N/A	X Walk 1 Width (in)	N/A	N/A	X Walk 2 Width (in)	N/A
	X Walk 1 Slope (%)	1.9		X Walk 2 Slope (%)	N/A
	X Walk 1 X Slope (%)	0.3		X Walk 2 X Slope (%)	N/A

N/A	Ramp inside XWalk1?	N/A	N/A	Ramp inside XWalk2?	N/A
	Road Slope (%)	N/A	N/A	Clear Space?	N/A
	Road X Slope (%)	N/A	N/A	Clear Space to XWalk (in)	N/A
N/A	Any Obstructions?	N/A	N/A	Storm Grate/Utility Hazard?	N/A
	Obstruction Type			Storm Grate/Utility Type	
		N/A			N/A
			Yes	Surface Condition? (G/P)	Good

Possible Solutions:

Remove & Replace Entire Ramp.
