Access Compliance Report

Public Rights-of-Way

(Curb Ramps)

Intersection ID: 3322	Main Street: CANTERBROOK_DR	Cross Street: TURTLE_CROSS_LN	Location: NE
ADA ID: ADB680145078	Ramp Type: Perp	Initial Pass/Fail: Fail	Overall Compliance: No
Severity Score: 8.75			
Codes/Mitigation Info/Possible Solution		Field Measurements/Component Compliance

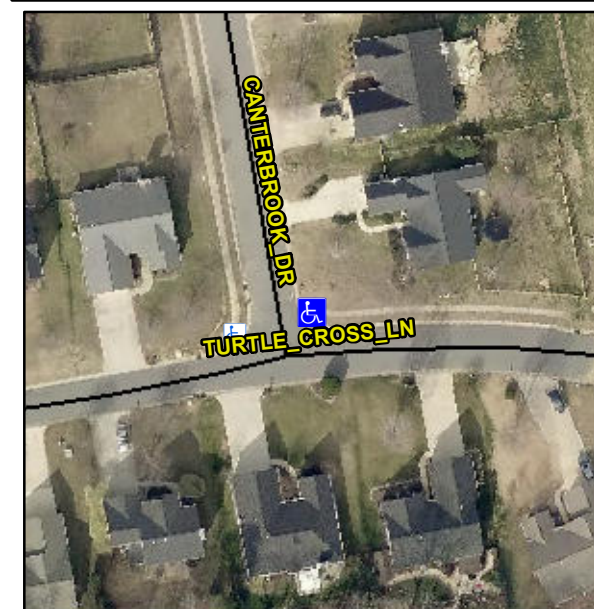
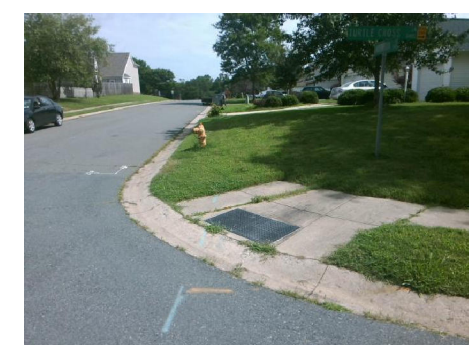
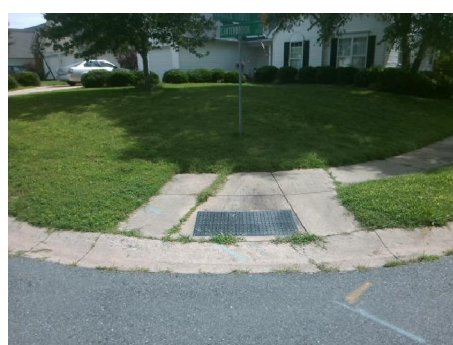
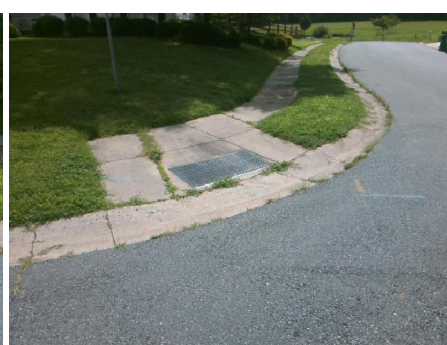
Not Found, R304.5.1

Compliance	Description	Data	Compliance	Description	Data
N/A	Ramp Length (in)	49.0	Yes	Ramp Slope (%)	5.3
No	Ramp Width (in)	42.0	Yes	Ramp XSlope (%)	0.5
N/A	Flare Type LT	N/A	N/A	Flare Type RT	N/A
N/A	Flare Slope LT (%)	N/A	N/A	Flare Slope RT (%)	N/A
N/A	Flare Traversable LT?	N/A	N/A	Flare Traversable RT?	N/A
N/A	Landing Length (in)	N/A	N/A	DWS Provided?	N/A
N/A	Landing Width (in)	N/A	N/A	DWS Contrast?	N/A
N/A	Landing Slope (%)	N/A	N/A	DWS Length (in)	N/A
N/A	Landing X Slope (%)	N/A	N/A	DWS Full Width?	N/A
N/A	Landing Curb? (Y/N)	N/A	N/A	DWS Offset (in)	N/A
N/A	Shared Landing?	N/A			
N/A	Gutter Ponding?	N/A	N/A	Gutter Slope (%)	N/A
N/A	Gutter Lip Ht (in)	N/A	N/A	Gutter X Slope (%)	N/A
N/A	Painted X Walk1?	No	N/A	Painted X Walk2?	N/A
	X Walk 1 Direction	To W		X Walk 2 Direction	N/A
N/A	X Walk 1 Width (in)	N/A	N/A	X Walk 2 Width (in)	N/A
	X Walk 1 Slope (%)	3.6		X Walk 2 Slope (%)	N/A
	X Walk 1 X Slope (%)	0.1		X Walk 2 X Slope (%)	N/A

N/A	Ramp inside XWalk1?	N/A	N/A	Ramp inside XWalk2?	N/A
	Road Slope (%)	N/A	N/A	Clear Space?	N/A
	Road X Slope (%)	N/A	N/A	Clear Space to XWalk (in)	N/A
N/A	Any Obstructions?	N/A	N/A	Storm Grate/Utility Hazard?	N/A
	Obstruction Type			Storm Grate/Utility Type	
		N/A			N/A
		Yes		Surface Condition? (G/P)	Good

Remove & Replace Entire Ramp.

Total Cost: \$ 1850.00
