Access Compliance Report

Public Rights-of-Way

(Curb Ramps)

Intersection ID: 10982	Main Street: LANECREST_DR	Cross Street: MENDHAM_DR	Location: NE
ADA ID: ADBF24089683	Ramp Type: ParaDiag	Initial Pass/Fail: Fail	Overall Compliance: No
		Severity Score: 12.5

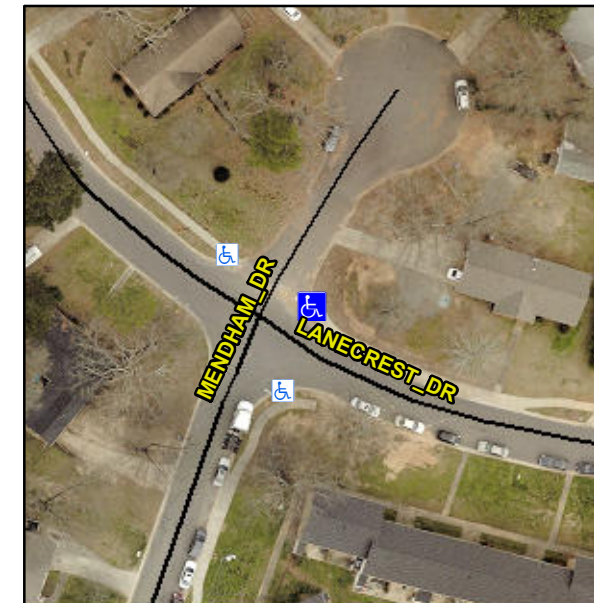
Compliance	Description	Data	Compliance	Description	Data
N/A	Ramp Length LT (in)	59.5	N/A	Ramp Length RT (in)	56.0
Yes	Ramp Width LT (in)	72.0	Yes	Ramp Width RT (in)	72.0
No	Ramp Slope LT (%)	9.1	Yes	Ramp Slope RT (%)	5.8
Yes	Ramp XSlope LT (%)	1.4	Yes	Ramp XSlope RT (%)	1.4
N/A	Landing Length (in)	N/A	N/A	DWS Provided?	N/A
N/A	Landing Width (in)	N/A	N/A	DWS Contrast?	N/A
N/A	Landing Slope (%)	N/A	N/A	DWS Length (in)	N/A
N/A	Landing X Slope (%)	N/A	N/A	DWS Full Width?	N/A
N/A	Landing Curb? (Y/N)	N/A	N/A	DWS Offset (in)	N/A
N/A	Shared Landing?	N/A			
N/A	Gutter Ponding?	N/A	N/A	Gutter Slope (%)	N/A
N/A	Gutter Lip Ht (in)	N/A	N/A	Gutter X Slope (%)	N/A
N/A	Painted X Walk1?	No	N/A	Painted X Walk2?	No
	X Walk 1 Direction	To NW		X Walk 2 Direction	To SW
N/A	X Walk 1 Width (in)	N/A	N/A	X Walk 2 Width (in)	N/A
	X Walk 1 Slope (%)	1.0		X Walk 2 Slope (%)	0.3
	X Walk 1 X Slope (%)	0.7		X Walk 2 X Slope (%)	0.2
N/A	Ramp inside XWalk1?	N/A	N/A	Ramp inside XWalk2?	N/A

Road Slope (%)	1.2	N/A	Clear Space?	N/A
	Road X Slope (%)	0.6	N/A	Clear Space to XWalk (in)	N/A
N/A	Any Obstructions?	N/A	N/A	Storm Grate/Utility Hazard?	N/A
	Obstruction Type			Storm Grate/Utility Type	
		N/A			N/A
			Yes	Surface Condition? (G/P)	Good
			N/A	Curb Slope (%)	13.7

Possible Solutions:

Remove & Replace Curb Ramp With Two New Directional Ramps or Equivalent.

R304.3.2
