Access Compliance Report

Public Rights-of-Way

(Curb Ramps)

Intersection ID: N/A	Main Street: WINSLET_DR	Cross Street: N/A	Location: NE
ADA ID: ADC32EEEC5B5	Ramp Type: PerpDiag	Initial Pass/Fail: Fail	Overall Compliance: No
		Severity Score: 25

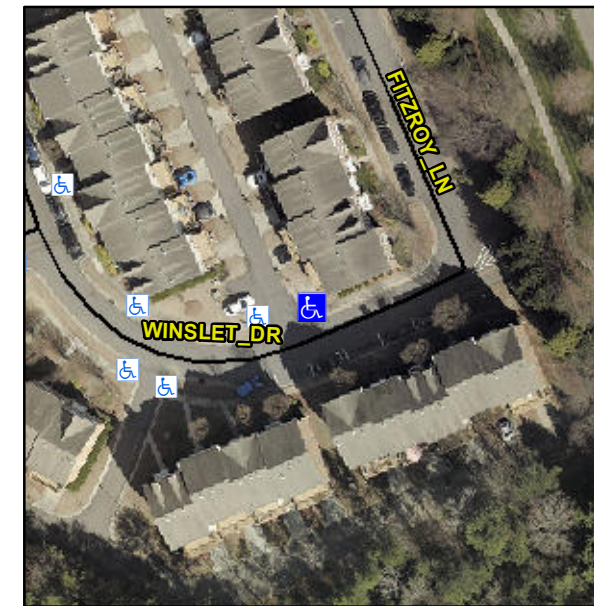
Compliance	Description	Data	Compliance	Description	Data
N/A	Ramp Length (in)	37.0	No	Ramp Slope (%)	14.9
Yes	Ramp Width (in)	48.0	Yes	Ramp XSlope (%)	1.3
N/A	Flare Type LT	N/A	N/A	Flare Type RT	N/A
N/A	Flare Slope LT (%)	N/A	N/A	Flare Slope RT (%)	N/A
N/A	Flare Traversable LT?	N/A	N/A	Flare Traversable RT?	N/A
N/A	Landing Length (in)	N/A	N/A	DWS Provided?	N/A
N/A	Landing Width (in)	N/A	N/A	DWS Contrast?	N/A
N/A	Landing Slope (%)	N/A	N/A	DWS Length (in)	N/A
N/A	Landing X Slope (%)	N/A	N/A	DWS Full Width?	N/A
N/A	Landing Curb? (Y/N)	N/A	N/A	DWS Offset (in)	N/A
N/A	Shared Landing?	N/A			
N/A	Gutter Ponding?	N/A	N/A	Gutter Slope (%)	N/A
N/A	Gutter Lip Ht (in)	N/A	N/A	Gutter X Slope (%)	N/A
N/A	Painted X Walk1?	No	N/A	Painted X Walk2?	No
	X Walk 1 Direction	To W		X Walk 2 Direction	To S
N/A	X Walk 1 Width (in)	N/A	N/A	X Walk 2 Width (in)	N/A
	X Walk 1 Slope (%)	0.7		X Walk 2 Slope (%)	0.5
	X Walk 1 X Slope (%)	0.7		X Walk 2 X Slope (%)	1.4

N/A	Ramp inside XWalk1?	N/A	N/A	Ramp inside XWalk2?	N/A
	Road Slope (%)	2.5	N/A	Clear Space?	N/A
	Road X Slope (%)	1.6	N/A	Clear Space to XWalk (in)	N/A
N/A	Any Obstructions?	N/A	N/A	Storm Grate/Utility Hazard?	N/A
	Obstruction Type			Storm Grate/Utility Type	
		N/A			N/A
			Yes	Surface Condition? (G/P)	Good

Remove & Replace Curb Ramp With Two New Directional Ramps or Equivalent.

Not Found, R304.2.2

Total Cost: \$ 3200.00
