# Access Compliance Report

## Public Rights-of-Way

### (Curb Ramps)

Intersection ID: 19169	Main Street: LIVINGSTON_DR	Cross Street: SARDIS_RD	Location: SW
ADA ID: ADC83FAE4800	Ramp Type: ParaDiag	Initial Pass/Fail: Fail	Overall Compliance: No
			Severity Score: 13.75

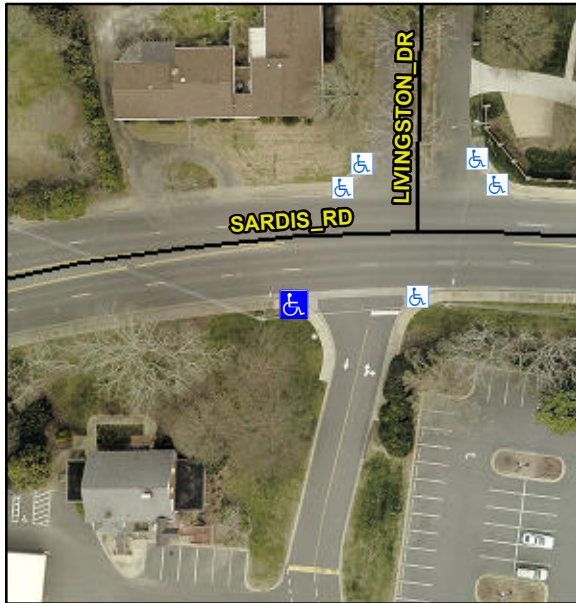
**R304.3.2, R304.5.3**

Compliance	Description	Data	Compliance	Description	Data
N/A	Ramp Length LT (in)	60.0	N/A	Ramp Length RT (in)	59.0
Yes	Ramp Width LT (in)	60.0	Yes	Ramp Width RT (in)	60.0
No	Ramp Slope LT (%)	9.3	Yes	Ramp Slope RT (%)	7.6
No	Ramp XSlope LT (%)	2.9	No	Ramp XSlope RT (%)	3.0
N/A	Landing Length (in)	N/A	N/A	DWS Provided?	N/A
N/A	Landing Width (in)	N/A	N/A	DWS Contrast?	N/A
N/A	Landing Slope (%)	N/A	N/A	DWS Length (in)	N/A
N/A	Landing X Slope (%)	N/A	N/A	DWS Full Width?	N/A
N/A	Landing Curb? (Y/N)	N/A	N/A	DWS Offset (in)	N/A
N/A	Shared Landing?	N/A			
N/A	Gutter Ponding?	N/A	N/A	Gutter Slope (%)	N/A
N/A	Gutter Lip Ht (in)	N/A	N/A	Gutter X Slope (%)	N/A
N/A	Painted X Walk1?	No	N/A	Painted X Walk2?	No
	X Walk 1 Direction	To E		X Walk 2 Direction	To N
N/A	X Walk 1 Width (in)	N/A	N/A	X Walk 2 Width (in)	N/A
	X Walk 1 Slope (%)	0.4		X Walk 2 Slope (%)	0.9
	X Walk 1 X Slope (%)	0.3		X Walk 2 X Slope (%)	0.1
N/A	Ramp inside XWalk1?	N/A	N/A	Ramp inside XWalk2?	N/A

Road Slope (%)	2.3	N/A	Clear Space?	N/A
	Road X Slope (%)	1.3	N/A	Clear Space to XWalk (in)	N/A
N/A	Any Obstructions?	N/A	N/A	Storm Grate/Utility Hazard?	N/A
	Obstruction Type			Storm Grate/Utility Type	
		N/A			N/A
			Yes	Surface Condition? (G/P)	Good
			N/A	Curb Slope (%)	8.8

**Remove & Replace Curb Ramp With Two New Directional Ramps or Equivalent.**
