Access Compliance Report

Public Rights-of-Way

(Curb Ramps)

Intersection ID: 14611	Main Street: CIRCLE_AV	Cross Street: S_CHASE_ST	Location: NW
ADA ID: ADCA8ACA4C63	Ramp Type: Directional1	Initial Pass/Fail: Fail	Overall Compliance: No
Severity Score: 1.25			
Codes/Mitigation Info/Possible Solution		Field Measurements/Component Compliance

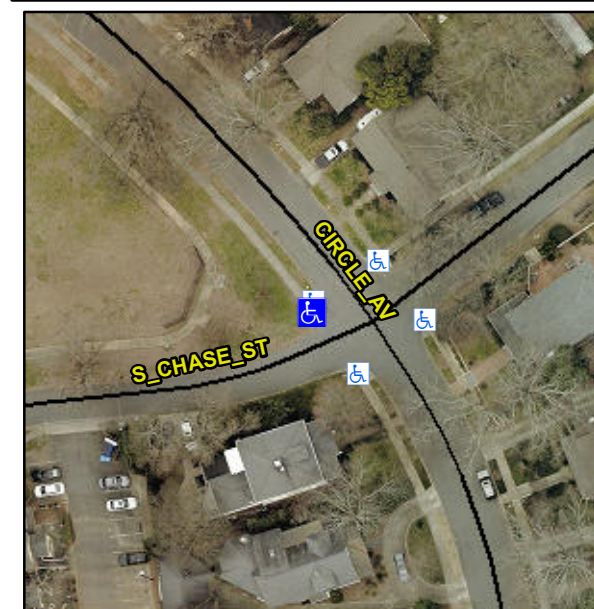
Compliance	Description	Data	Compliance	Description	Data
N/A	Ramp Length (in)	31.0	N/A	Grade Break?	N/A
Yes	Ramp Width (in)	48.0	N/A	Grade Break Slope (%)	0.0
Yes	Ramp Slope (%)	5.9	N/A	Grade Break XSlope (%)	0.0
No	Ramp XSlope (%)	2.5			
N/A	Flare Type LT	N/A	N/A	Flare Type RT	N/A
N/A	Flare Slope LT (%)	N/A	N/A	Flare Slope RT (%)	0.0
N/A	Flare Traversable LT?	N/A	N/A	Flare Traversable RT?	N/A
N/A	Landing Length (in)	0.0	N/A	DWS Provided?	N/A
N/A	Landing Width (in)	0.0	N/A	DWS Contrast?	N/A
N/A	Landing Slope (%)	0.0	N/A	DWS Length (in)	N/A
N/A	Landing X Slope (%)	0.0	N/A	DWS Full Width?	N/A
N/A	Landing Curb? (Y/N)	N/A	N/A	DWS Offset LT (in)	N/A
N/A	Shared Landing?	N/A	N/A	DWS Offset RT (in)	N/A
N/A	Gutter Ponding?	0.0	N/A	Gutter Slope (%)	N/A
N/A	Gutter Lip Ht (in)	0.0	N/A	Gutter X Slope (%)	N/A
N/A	Painted X Walk1?	No		Road Slope (%)	4.2
	X Walk 1 Direction	To SE		Road X Slope (%)	2.6
	X Walk 1 Width (in)	N/A		Clear Space?	N/A

X Walk 1 Slope (%)	4.2	N/A	Clear Space to XWalk (in)	N/A
	X Walk 1 X Slope (%)	2.6	N/A	Storm Grate/Utility Hazard?	N/A
N/A	Ramp inside XWalk1?	N/A		Storm Grate/Utility Type	
N/A	Any Obstructions?	N/A			N/A
	Obstruction Type		Yes	Surface Condition? (G/P)	Good
			N/A	Curb Slope (%)	8.7

Remove & Replace Entire Ramp.
