# Access Compliance Report

## Public Rights-of-Way

### (Curb Ramps)

| Intersection ID: 18287 | Main Street: BEECHDALE_DR | Cross Street: MCLAUGHLIN_DR | Location: NE |

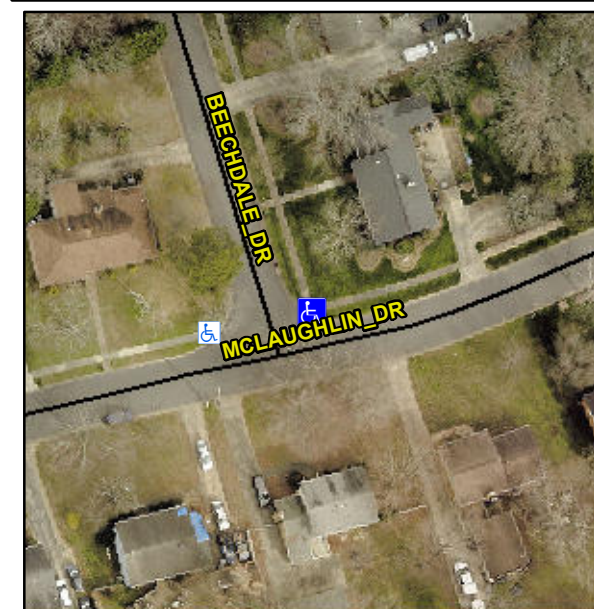
**Not Found, R304.5.1, R304.2.2, R304.5.3**

| Compliance | Description | Data | Compliance | Description | Data |
|---|---|---|---|---|---|
| N/A | Ramp Length (in) | 59.0 | No | Ramp Slope (%) | 9.9 |
| No | Ramp Width (in) | 40.0 | No | Ramp XSlope (%) | 9.9 |

**Remove & Replace Curb Ramp With Two New Directional Ramps or Equivalent.**

Total Cost: \$ 3200.00
