Access Compliance Report

Public Rights-of-Way

(Curb Ramps)

Intersection ID: 9284	Main Street: HARRISON_ST	Cross Street: N/A	Location:	N
ADA ID: ADDA931C77AA	Ramp Type: Perp	Initial Pass/Fail: Fail	Overall Compliance: No	Severity Score: 22.5
Codes/Mitigation Info/Possible Solution		Field Measurements/Component Compliance

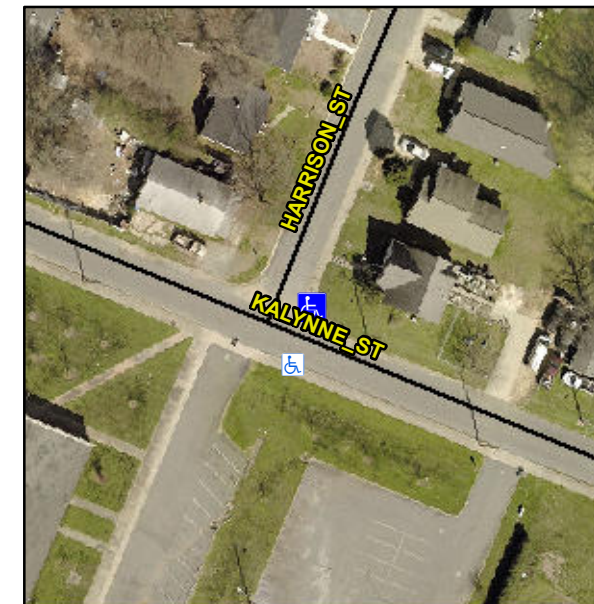
Not Found, R304.5.1, R304.2.2, R304.5.3

Compliance	Description	Data	Compliance	Description	Data
N/A	Ramp Length (in)	44.0	No	Ramp Slope (%)	9.8
No	Ramp Width (in)	46.0	No	Ramp XSlope (%)	4.0
N/A	Flare Type LT	N/A	N/A	Flare Type RT	N/A
N/A	Flare Slope LT (%)	N/A	N/A	Flare Slope RT (%)	N/A
N/A	Flare Traversable LT?	N/A	N/A	Flare Traversable RT?	N/A
N/A	Landing Length (in)	N/A	N/A	DWS Provided?	N/A
N/A	Landing Width (in)	N/A	N/A	DWS Contrast?	N/A
N/A	Landing Slope (%)	N/A	N/A	DWS Length (in)	N/A
N/A	Landing X Slope (%)	N/A	N/A	DWS Full Width?	N/A
N/A	Landing Curb? (Y/N)	N/A	N/A	DWS Offset (in)	N/A
N/A	Shared Landing?	N/A			
N/A	Gutter Ponding?	N/A	N/A	Gutter Slope (%)	N/A
N/A	Gutter Lip Ht (in)	N/A	N/A	Gutter X Slope (%)	N/A
N/A	Painted X Walk1?	No	N/A	Painted X Walk2?	N/A
	X Walk 1 Direction	To S		X Walk 2 Direction	N/A
N/A	X Walk 1 Width (in)	N/A	N/A	X Walk 2 Width (in)	N/A
	X Walk 1 Slope (%)	3.6		X Walk 2 Slope (%)	N/A
	X Walk 1 X Slope (%)	1.5		X Walk 2 X Slope (%)	N/A

N/A	Ramp inside XWalk1?	N/A	N/A	Ramp inside XWalk2?	N/A
	Road Slope (%)	N/A	N/A	Clear Space?	N/A
	Road X Slope (%)	N/A	N/A	Clear Space to XWalk (in)	N/A
N/A	Any Obstructions?	N/A	N/A	Storm Grate/Utility Hazard?	N/A
	Obstruction Type			Storm Grate/Utility Type	
		N/A			N/A
			Yes	Surface Condition? (G/P)	Good

Possible Solutions:

Remove & Replace Entire Ramp.

Total Cost: \$ 1850.00
