# Access Compliance Report

## Public Rights-of-Way

### (Curb Ramps)

Intersection ID: 44933	Main Street: ACORN_FOREST_LN	Cross Street: BRUMIT_LN	Location: E
ADA ID: ADDB95A0219F	Ramp Type: Perp	Initial Pass/Fail: Fail	Overall Compliance: No
Severity Score: 37.5			
Codes/Mitigation Info/Possible Solution		Field Measurements/Component Compliance

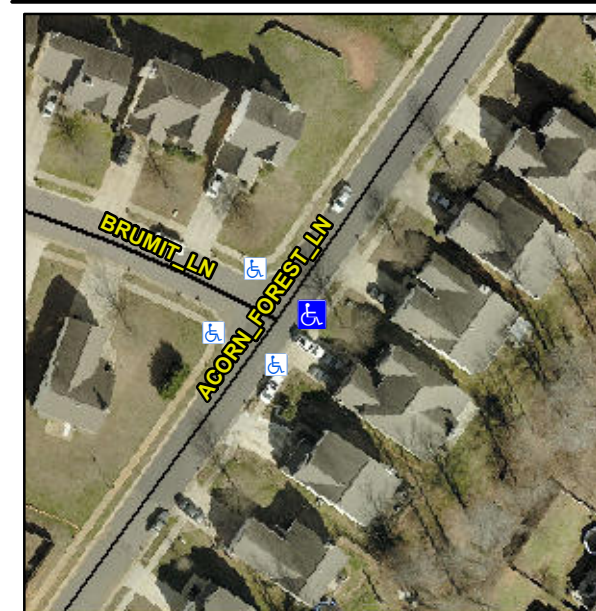
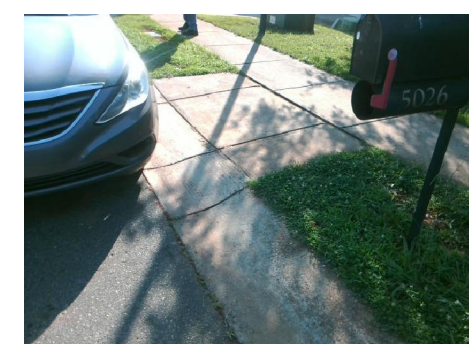
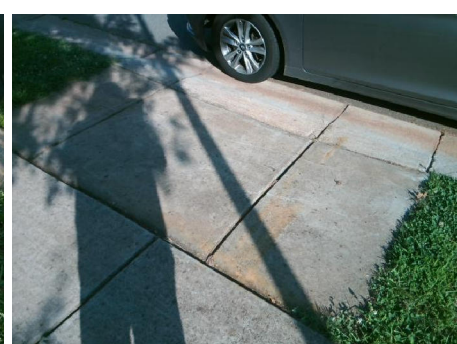
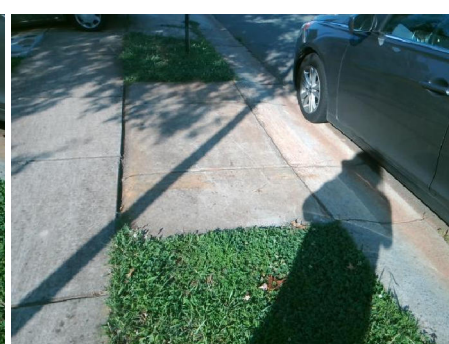
**Not Found, R304.2.2, R304.5.3**

Compliance	Description	Data	Compliance	Description	Data
N/A	Ramp Length (in)	48.0	No	Ramp Slope (%)	20.0
Yes	Ramp Width (in)	50.0	No	Ramp XSlope (%)	5.9
N/A	Flare Type LT	N/A	N/A	Flare Type RT	N/A
N/A	Flare Slope LT (%)	N/A	N/A	Flare Slope RT (%)	N/A
N/A	Flare Traversable LT?	N/A	N/A	Flare Traversable RT?	N/A
N/A	Landing Length (in)	N/A	N/A	DWS Provided?	N/A
N/A	Landing Width (in)	N/A	N/A	DWS Contrast?	N/A
N/A	Landing Slope (%)	N/A	N/A	DWS Length (in)	N/A
N/A	Landing X Slope (%)	N/A	N/A	DWS Full Width?	N/A
N/A	Landing Curb? (Y/N)	N/A	N/A	DWS Offset (in)	N/A
N/A	Shared Landing?	N/A			
N/A	Gutter Ponding?	N/A	N/A	Gutter Slope (%)	N/A
N/A	Gutter Lip Ht (in)	N/A	N/A	Gutter X Slope (%)	N/A
N/A	Painted X Walk1?	No	N/A	Painted X Walk2?	N/A
	X Walk 1 Direction	To NW		X Walk 2 Direction	N/A
N/A	X Walk 1 Width (in)	N/A	N/A	X Walk 2 Width (in)	N/A
	X Walk 1 Slope (%)	2.9		X Walk 2 Slope (%)	N/A
	X Walk 1 X Slope (%)	5.7		X Walk 2 X Slope (%)	N/A

N/A	Ramp inside XWalk1?	N/A	N/A	Ramp inside XWalk2?	N/A
	Road Slope (%)	N/A	N/A	Clear Space?	N/A
	Road X Slope (%)	N/A	N/A	Clear Space to XWalk (in)	N/A
N/A	Any Obstructions?	N/A	N/A	Storm Grate/Utility Hazard?	N/A
	Obstruction Type			Storm Grate/Utility Type	
		N/A			N/A
		Yes		Surface Condition? (G/P)	Good

**Remove & Replace Entire Ramp.**
