Access Compliance Report

Public Rights-of-Way

(Curb Ramps)

Intersection ID: 24302	Main Street: PRESCOTT_POND_LN	Cross Street: RATHLIN_CT	Location:	N
ADA ID: ADE4607A4894	Ramp Type: PerpDiag	Initial Pass/Fail: Fail	Overall Compliance: No	Severity Score: 22.5
Codes/Mitigation Info/Possible Solution		Field Measurements/Component Compliance

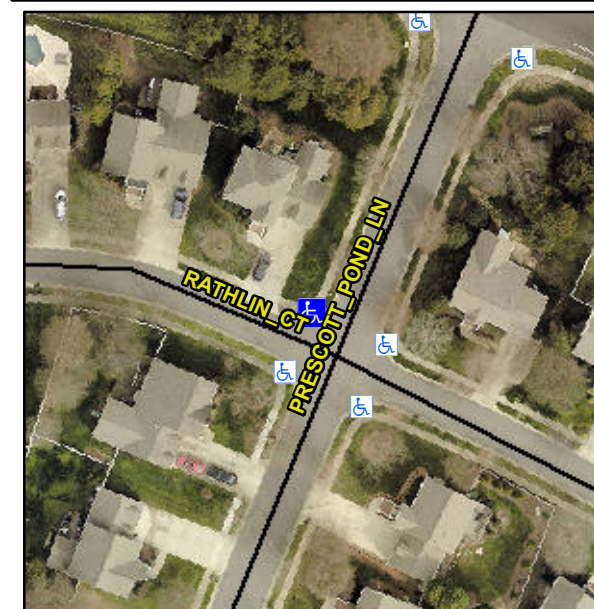
Not Found, R304.5.1, R304.2.2, R304.5.3

Compliance	Description	Data	Compliance	Description	Data
N/A	Ramp Length (in)	46.0	No	Ramp Slope (%)	8.8
No	Ramp Width (in)	47.0	No	Ramp XSlope (%)	2.7
N/A	Flare Type LT	N/A	N/A	Flare Type RT	N/A
N/A	Flare Slope LT (%)	N/A	N/A	Flare Slope RT (%)	N/A
N/A	Flare Traversable LT?	N/A	N/A	Flare Traversable RT?	N/A
N/A	Landing Length (in)	N/A	N/A	DWS Provided?	N/A
N/A	Landing Width (in)	N/A	N/A	DWS Contrast?	N/A
N/A	Landing Slope (%)	N/A	N/A	DWS Length (in)	N/A
N/A	Landing X Slope (%)	N/A	N/A	DWS Full Width?	N/A
N/A	Landing Curb? (Y/N)	N/A	N/A	DWS Offset (in)	N/A
N/A	Shared Landing?	N/A			
N/A	Gutter Ponding?	N/A	N/A	Gutter Slope (%)	N/A
N/A	Gutter Lip Ht (in)	N/A	N/A	Gutter X Slope (%)	N/A
N/A	Painted X Walk1?	No	N/A	Painted X Walk2?	No
	X Walk 1 Direction	To SW		X Walk 2 Direction	To SE
N/A	X Walk 1 Width (in)	N/A	N/A	X Walk 2 Width (in)	N/A
	X Walk 1 Slope (%)	3.2		X Walk 2 Slope (%)	7.6
	X Walk 1 X Slope (%)	3.1		X Walk 2 X Slope (%)	1.5

N/A	Ramp inside XWalk1?	N/A	N/A	Ramp inside XWalk2?	N/A
	Road Slope (%)	2.0	N/A	Clear Space?	N/A
	Road X Slope (%)	5.3	N/A	Clear Space to XWalk (in)	N/A
N/A	Any Obstructions?	N/A	N/A	Storm Grate/Utility Hazard?	N/A
	Obstruction Type			Storm Grate/Utility Type	
		N/A			N/A
			Yes	Surface Condition? (G/P)	Good

Possible Solutions:

Remove & Replace Curb Ramp With Two New Directional Ramps or Equivalent.
