Access Compliance Report Public Rights-of-Way (Curb Ramps)

Intersection ID: 28654 Main Street: HAMPTON_PLACE_DR Cross Street: SHADYSIDE_CT Location: S

ADA ID: ADEA2135FA7E Ramp Type: Perp Initial Pass/Fail: Fail Overall Compliance: No Severity Score: 10

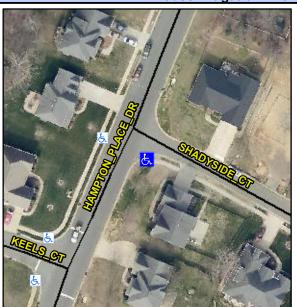
Street 1 Name HAMPTON PLACE DR
Stop Condition-Street 2 None
Street 2 Name N/A
Stop Condition-Street 1 N/A

Not Found, R304.5.1, R304.5.3

Possible Solutions:

Remove & Replace Entire Ramp.
