# Access Compliance Report

## Public Rights-of-Way

### (Curb Ramps)

Intersection ID: 49926	Main Street: CAMPBELL_HALL_CT	Cross Street: WOBURN_RD	Location: SE
ADA ID: ADED2299AF0E	Ramp Type: Perp	Initial Pass/Fail: Fail	Overall Compliance: No
Severity Score: 12.5			
Codes/Mitigation Info/Possible Solution		Field Measurements/Component Compliance

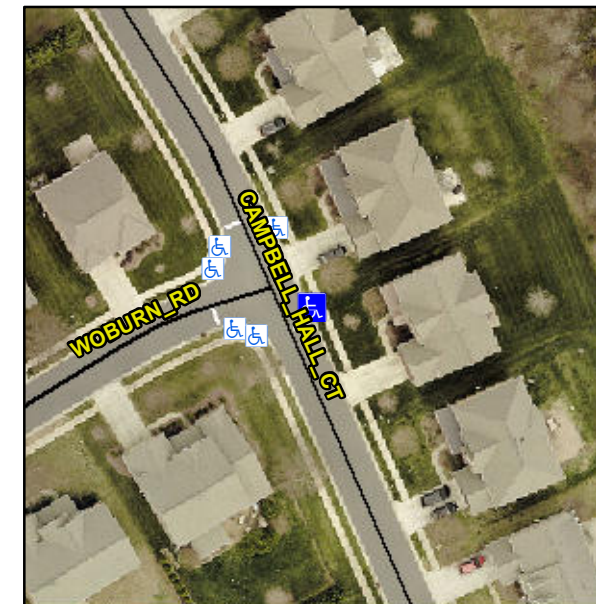
**Not Found, R304.2.2**

Compliance	Description	Data	Compliance	Description	Data
N/A	Ramp Length (in)	47.0	No	Ramp Slope (%)	9.1
Yes	Ramp Width (in)	48.0	Yes	Ramp XSlope (%)	0.5
N/A	Flare Type LT	N/A	N/A	Flare Type RT	N/A
N/A	Flare Slope LT (%)	N/A	N/A	Flare Slope RT (%)	N/A
N/A	Flare Traversable LT?	N/A	N/A	Flare Traversable RT?	N/A
N/A	Landing Length (in)	N/A	N/A	DWS Provided?	N/A
N/A	Landing Width (in)	N/A	N/A	DWS Contrast?	N/A
N/A	Landing Slope (%)	N/A	N/A	DWS Length (in)	N/A
N/A	Landing X Slope (%)	N/A	N/A	DWS Full Width?	N/A
N/A	Landing Curb? (Y/N)	N/A	N/A	DWS Offset (in)	N/A
N/A	Shared Landing?	N/A			
N/A	Gutter Ponding?	N/A	N/A	Gutter Slope (%)	N/A
N/A	Gutter Lip Ht (in)	N/A	N/A	Gutter X Slope (%)	N/A
N/A	Painted X Walk1?	No	N/A	Painted X Walk2?	N/A
	X Walk 1 Direction	To SW		X Walk 2 Direction	N/A
N/A	X Walk 1 Width (in)	N/A	N/A	X Walk 2 Width (in)	N/A
	X Walk 1 Slope (%)	3.3		X Walk 2 Slope (%)	N/A
	X Walk 1 X Slope (%)	1.3		X Walk 2 X Slope (%)	N/A

**Remove & Replace Entire Ramp.**

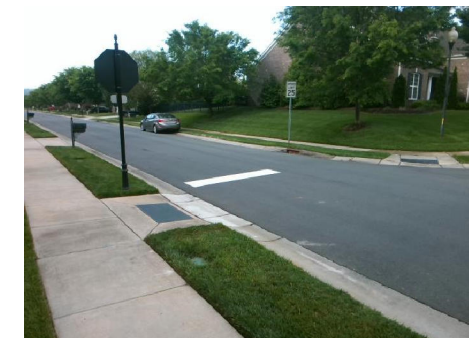
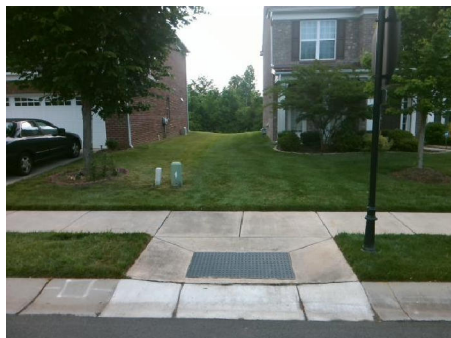
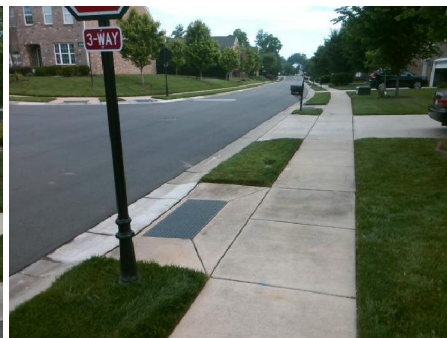
N/A	Ramp inside XWalk1?	N/A	N/A	Ramp inside XWalk2?	N/A
	Road Slope (%)	N/A	N/A	Clear Space?	N/A
	Road X Slope (%)	N/A	N/A	Clear Space to XWalk (in)	N/A
N/A	Any Obstructions?	N/A	N/A	Storm Grate/Utility Hazard?	N/A
	Obstruction Type			Storm Grate/Utility Type	
		N/A			N/A
			Yes	Surface Condition? (G/P)	Good
