## Access Compliance Report Public Rights-of-Way (Curb Ramps)

Intersection ID: 10037649 Main Street: SEVENTY\_SEVEN\_CENTER\_DRCross Street: N/A Location: SW

ADA ID: ADF28E618EFF Ramp Type: Perp Initial Pass/Fail: Fail Overall Compliance: No Severity Score: 12.5

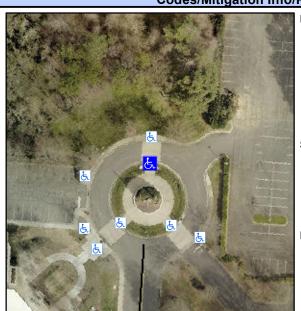
o/Possible Solution		Field Measurements/Component Compliance						
Possible Solutions:		Compliance Description		Data	Data Compliance Descrip		ption Data	
Remove & Replace Er	ntire Ramp.	N/A	Ramp Length (in)	46.0	No	Ramp Slope (%)	10.7

•	•	Yes	Ramp Width (in)	48.0	Yes	Ramp XSlope (%)	0.3	
		N/A	Flare Type LT	N/A	N/A	Flare Type RT	N/A	
		N/A	Flare Slope LT (%)	N/A	N/A	Flare Slope RT (%)	N/A	
		N/A	Flare Traversable LT?	N/A	N/A	Flare Traversable RT?	N/A	
		N/A	Landing Length (in)	N/A	N/A	DWS Provided?	N/A	
Surveyor Notes:		N/A	Landing Width (in)	N/A	N/A	DWS Contrast?	N/A	
N/A		N/A	Landing Slope (%)	N/A	N/A	DWS Length (in)	N/A	
		N/A	Landing X Slope (%)	N/A	N/A	DWS Full Width?	N/A	
		N/A	Landing Curb? (Y/N)	N/A	N/A	DWS Offset (in)	N/A	
		N/A	Shared Landing?	N/A				
PROW/ADA:		N/A	Gutter Ponding?	N/A	N/A	Gutter Slope (%)	N/A	
Not Found, R304.2.2		N/A	Gutter Lip Ht (in)	N/A	N/A	Gutter X Slope (%)	N/A	
		N/A	Painted X Walk1?	No	N/A	Painted X Walk2?	N/A	
			X Walk 1 Direction	To N		X Walk 2 Direction	N/A	
		N/A	X Walk 1 Width (in)	N/A	N/A	X Walk 2 Width (in)	N/A	
			X Walk 1 Slope (%)	2.2		X Walk 2 Slope (%)	N/A	
			X Walk 1 X Slope (%)	0.3		X Walk 2 X Slope (%)	N/A

N/A	Ramp inside XWalk1?	N/A	N/A	Ramp inside XWalk2?	N/A	
			Road Slope (%)	N/A	N/A	Clear Space?	N/A	
			Road X Slope (%)	N/A	N/A	Clear Space to XWalk (in)	N/A	
		N/A	Any Obstructions?	N/A	N/A	Storm Grate/Utility Hazard?	N/A	
Total Cost: \$	\$ 1850.00		Obstruction Type		Į.	Storm Grate/Utility Type		
				N/A			N/A	
					Yes	Surface Condition? (G/P)	Good
