## **Access Compliance Report Public Rights-of-Way** (Curb Ramps)

Intersection ID: 15905 Main Street: PEMBROKE\_AV Cross Street: QUEENS\_RD Location: SW Ramp Type: Directional1 **Severity Score:** ADA ID: ADF9C4EA799E Initial Pass/Fail: Fail **Overall Compliance: No** 12.5

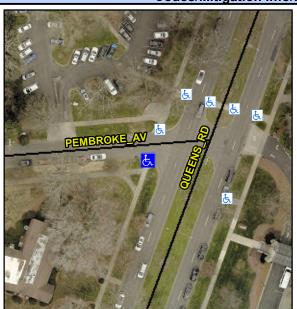
Field Measurements/Component Compliance							
	Compliance Description		Data	Compliance Description		Data	
	N/A	Ramp Length (in)	125.0	N/A	Grade Break?	N/A	
	Yes	Ramp Width (in)	48.0	N/A	Grade Break Slope (%)	0.0	
	Yes	Ramp Slope (%)	2.9	N/A	Grade Break XSlope (%)	0.0	
	No	Ramp XSlope (%)	5.5				
	N/A	Flare Type LT	N/A	N/A	Flare Type RT	N/A	
	N/A	Flare Slope LT (%)	N/A	N/A	Flare Slope RT (%)	0.0	
	N/A	Flare Traversable LT?	N/A	N/A	Flare Traversable RT?	N/A	
	N/A	Landing Length (in)	0.0	N/A	DWS Provided?	N/A	
	N/A	Landing Width (in)	0.0	N/A	DWS Contrast?	N/A	
	N/A	Landing Slope (%)	0.0	N/A	DWS Length (in)	N/A	
	N/A	Landing X Slope (%)	0.0	N/A	DWS Full Width?	N/A	
	N/A	Landing Curb? (Y/N)	N/A	N/A	DWS Offset LT (in)	N/A	
	N/A	Shared Landing?	N/A	N/A	DWS Offset RT (in)	N/A	
	N/A	Gutter Ponding?	0.0	N/A	Gutter Slope (%)	N/A	
	N/A	Gutter Lip Ht (in)	0.0	N/A	Gutter X Slope (%)	N/A	
	N/A	Painted X Walk1?	No		Road Slope (%)	3.1

X Walk 1 Direction	To N		Road X Slope (%)	4.9	
		X Walk 1 Width (in)	N/A		Clear Space?	N/A	
		X Walk 1 Slope (%)	3.1	N/A	Clear Space to XWalk (in)	N/A	
		X Walk 1 X Slope (%)	4.9	N/A	Storm Grate/Utility Hazard?	N/A	
	N/A	Ramp inside XWalk1?	N/A		Storm Grate/Utility Type		
	N/A	Any Obstructions?	N/A			N/A	
		Obstruction Type		Yes	Surface Condition? (G/P)	Good	
			N/A	N/A	Curb Slope (%)	11.9

Possible Solutions:					
Remove & Replace Entire Ramp.					
Surveyor Notes:					
N/A					
PROW/ADA:					
R304.5.3
