Access Compliance Report

Public Rights-of-Way

(Curb Ramps)

Intersection ID: 30000	Main Street: OAKBORO_LN	Cross Street: OLD_CAROLINA_DR	Location: NW
ADA ID: AE09FE5202A7	Ramp Type: PerpDiag	Initial Pass/Fail: Fail	Overall Compliance: No
		Severity Score: 21.25

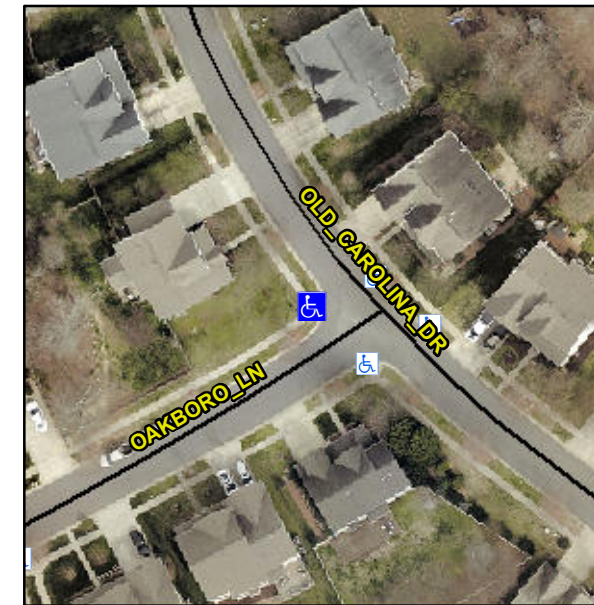
Not Found, R304.5.1, R304.5.3

Compliance	Description	Data	Compliance	Description	Data
N/A	Ramp Length (in)	70.0	Yes	Ramp Slope (%)	6.0
No	Ramp Width (in)	47.5	No	Ramp XSlope (%)	5.1
N/A	Flare Type LT	N/A	N/A	Flare Type RT	N/A
N/A	Flare Slope LT (%)	N/A	N/A	Flare Slope RT (%)	N/A
N/A	Flare Traversable LT?	N/A	N/A	Flare Traversable RT?	N/A
N/A	Landing Length (in)	N/A	N/A	DWS Provided?	N/A
N/A	Landing Width (in)	N/A	N/A	DWS Contrast?	N/A
N/A	Landing Slope (%)	N/A	N/A	DWS Length (in)	N/A
N/A	Landing X Slope (%)	N/A	N/A	DWS Full Width?	N/A
N/A	Landing Curb? (Y/N)	N/A	N/A	DWS Offset (in)	N/A
N/A	Shared Landing?	N/A			
N/A	Gutter Ponding?	N/A	N/A	Gutter Slope (%)	N/A
N/A	Gutter Lip Ht (in)	N/A	N/A	Gutter X Slope (%)	N/A
N/A	Painted X Walk1?	No	N/A	Painted X Walk2?	No
	X Walk 1 Direction	To S		X Walk 2 Direction	To E
N/A	X Walk 1 Width (in)	N/A	N/A	X Walk 2 Width (in)	N/A
	X Walk 1 Slope (%)	0.9		X Walk 2 Slope (%)	0.7
	X Walk 1 X Slope (%)	1.0		X Walk 2 X Slope (%)	1.0

Possible Solutions:

Remove & Replace Curb Ramp With Two New Directional Ramps or Equivalent.
